Incident reporting bulletin

Issue 1

January 2021

A 'roll-off' that caused a 'fall from height'

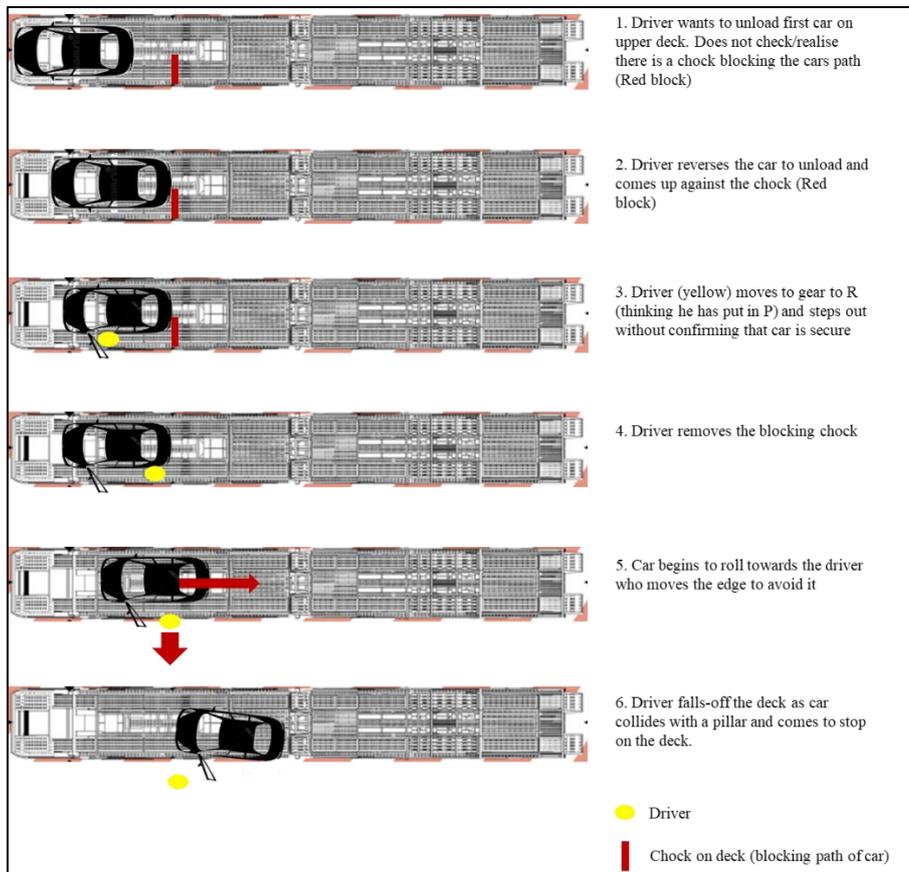
An LSP was unloading cars in an OEM compound. Whilst unloading the front unit on the truck upper deck (above driver cabin), he stopped approximately halfway along the truck upper deck to remove a chock that was blocking the car from reversing off. This is **error number 1**: the driver should have removed the chock *before* getting in the car to unload.

Instead of then stopping the car securely (with the gear in "Park" position, handbrake applied, engine off), the driver decided to open door with gear still in "Reverse", handbrake off and ignition still running **error number 2**: the driver did not securely park the car *before* exiting.

As the driver stepped out and removed the chock, the car – with the door still open – started rolling backwards and hit him causing him to fall from the deck.

Figure 1 Visual representation of events leading to the accident

Had the driver followed the safety principles in the Guidelines, this incident could have been prevented from occurring. Below is a list of steps from the Guidelines that were *not* followed by the driver which could have avoided the accident:

1. **Deck preparation** (p. 7 - Step 2A): If the deck had been properly prepared after unloading each unit, the chock would not have been in the path to block the car.
2. **Checking & confirming safe areas to walk after exiting car** (p. 4 – Basic 4): if the driver had checked the deck condition then he would have seen the chock that was blocking the car and removed it earlier rather than stopping midway through the process to remove it.
3. **4-Step Parking & Confirmation** (p. 3 – Basic 3): if the driver applied the 4-Step Parking rule before stepping out of the car, the car would not have moved as they removed the chock.
