Making the industry safer - Reducing accidents in FVL

2019 incidents & analysis

OCTOBER 2020

The Association
of European
Vehicle Logistics

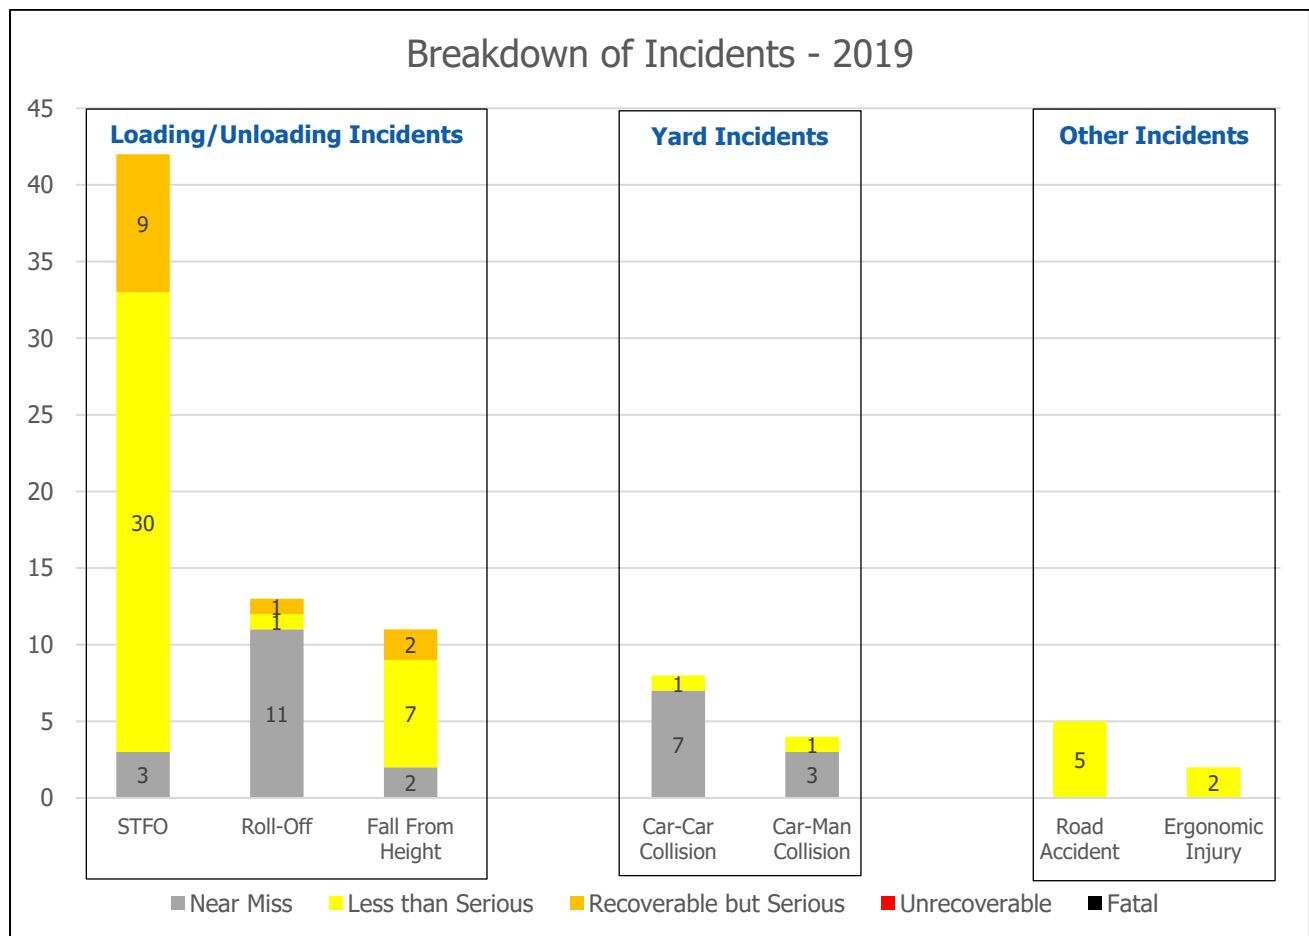
Fig. 1 – Incidents breakdown for 2019

85 truck loading/unloading incidents have been reported for 2019, as shown in Fig. 1 below.

The most common type of incident reported for 2019 is Slips, Trips, Falls and Other personal injuries (STFOs). Of the 42 STFOs in 2019, 9 accidents resulted in 'Recoverable but Serious' injuries, whilst all other injuries were less than serious (21%). The proportion of Serious injuries makes **STFOs the most serious incident category for the incidents reported in 2019**.

Roll-offs are the second most common incident in 2019, followed by Fall from height incidents. The fall from height incidents reported in 2019 led to proportionally more severe injuries than any other category apart from Slip, Trips and Falls (STFs) with 2 'Recoverable but Serious' injuries out of a total of 11 incidents (18%).

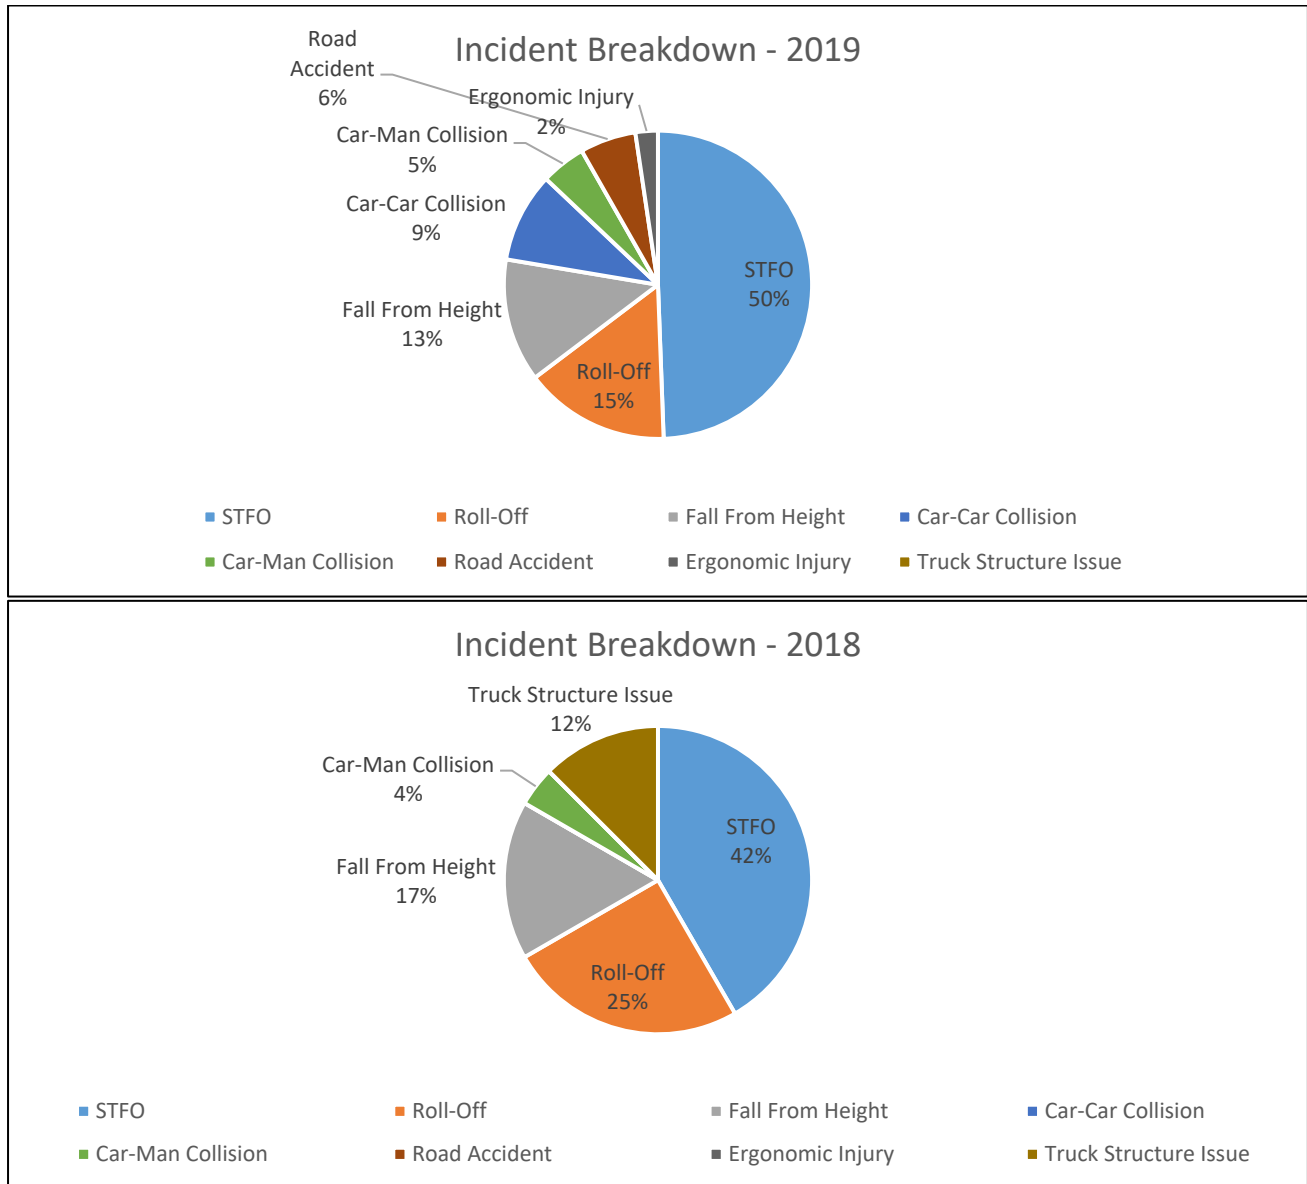
Fig. 2a – Incidents breakdown comparison for 2019 & 2018

Only 24 incidents were uploaded in 2018 therefore it is not possible to do a direct comparison between the reported incidents. Nonetheless, it is possible to do a comparison between the ratios of incidents reported, as shown in Fig. 2a below.

The data shown in Fig. 2a, indicates that STFOs *do* constitute the majority of the reported incidents in the FVL industry (~ 45%), followed by roll-offs (~ 20%) and falls from height (~ 15%). The data also indicates that approximately 5% of FVL industry incidents are car-man collisions.

From the graphs above (Fig. 2a), it is not yet possible to reach conclusions on car-car collisions, road accidents and ergonomic injuries as these incidents were only reported in 2019. Similarly, it is not possible to infer any trends related to truck structure-related incidents (e.g. deck collapse/fires) as these were only reported in 2018.

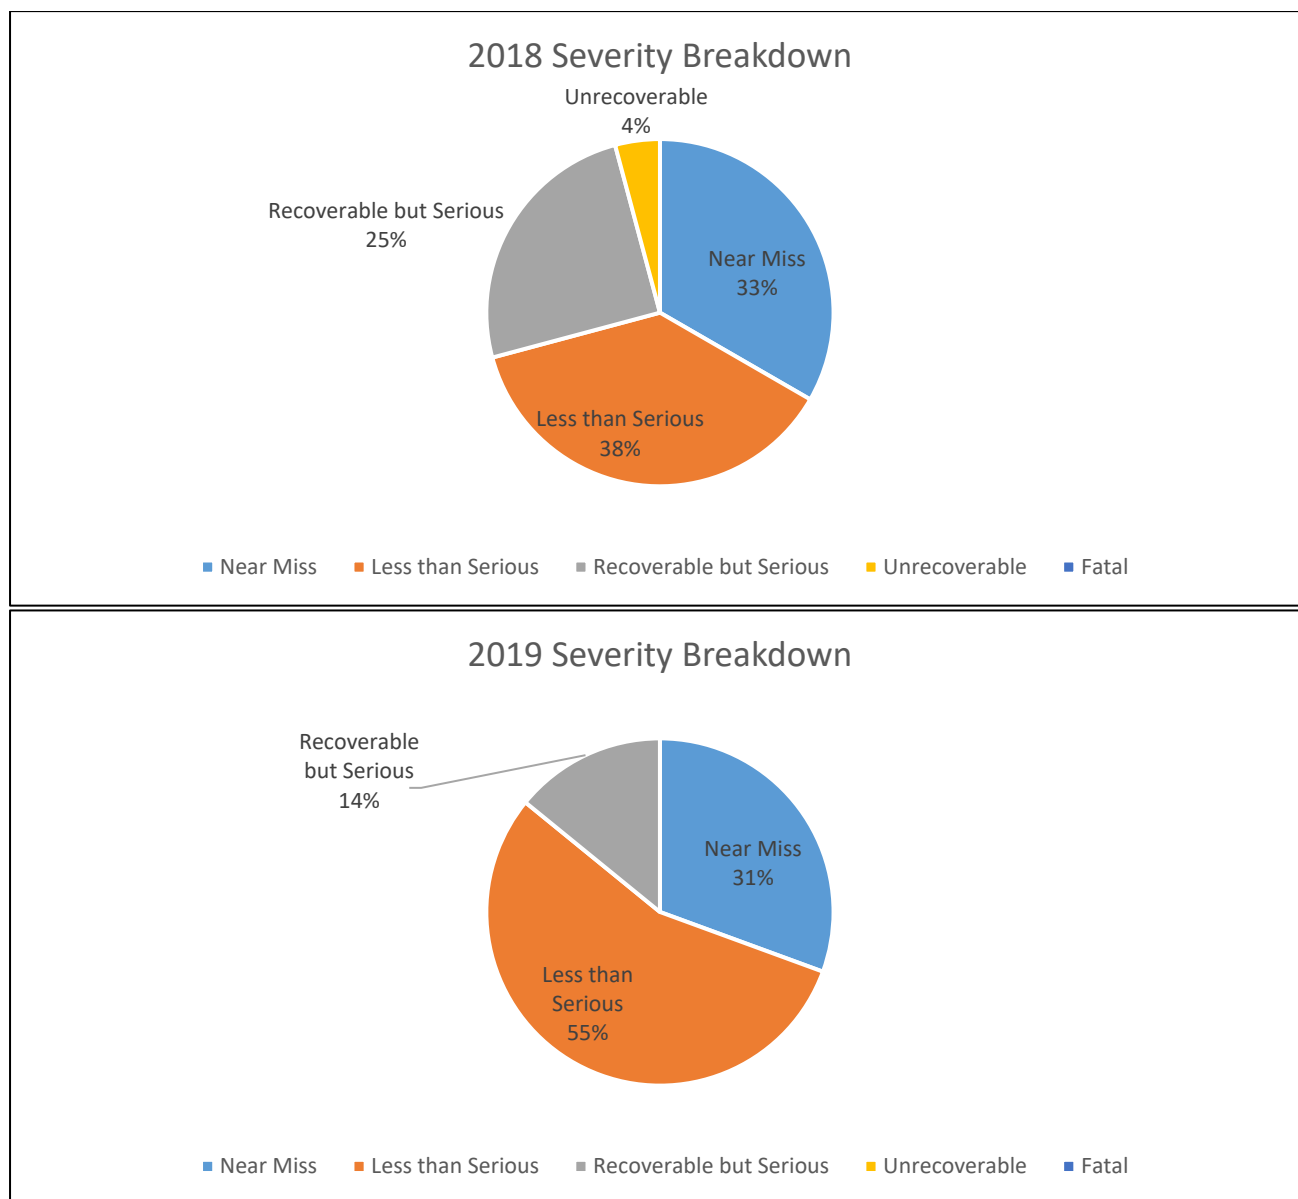
Fig. 2b – Incidents severity comparison for 2019 & 2018

It is also noteworthy to compare the proportions of severe accidents reported in 2018 and 2019 as shown in Fig. 2b below.

Fig. 2b clearly shows that even though fewer incidents were reported in 2018, a larger proportion of those were more serious than the ones reported in 2019. The proportion of Recoverable but Serious incidents was 11% higher in 2018, and there was also an Unrecoverable incident reported that year.

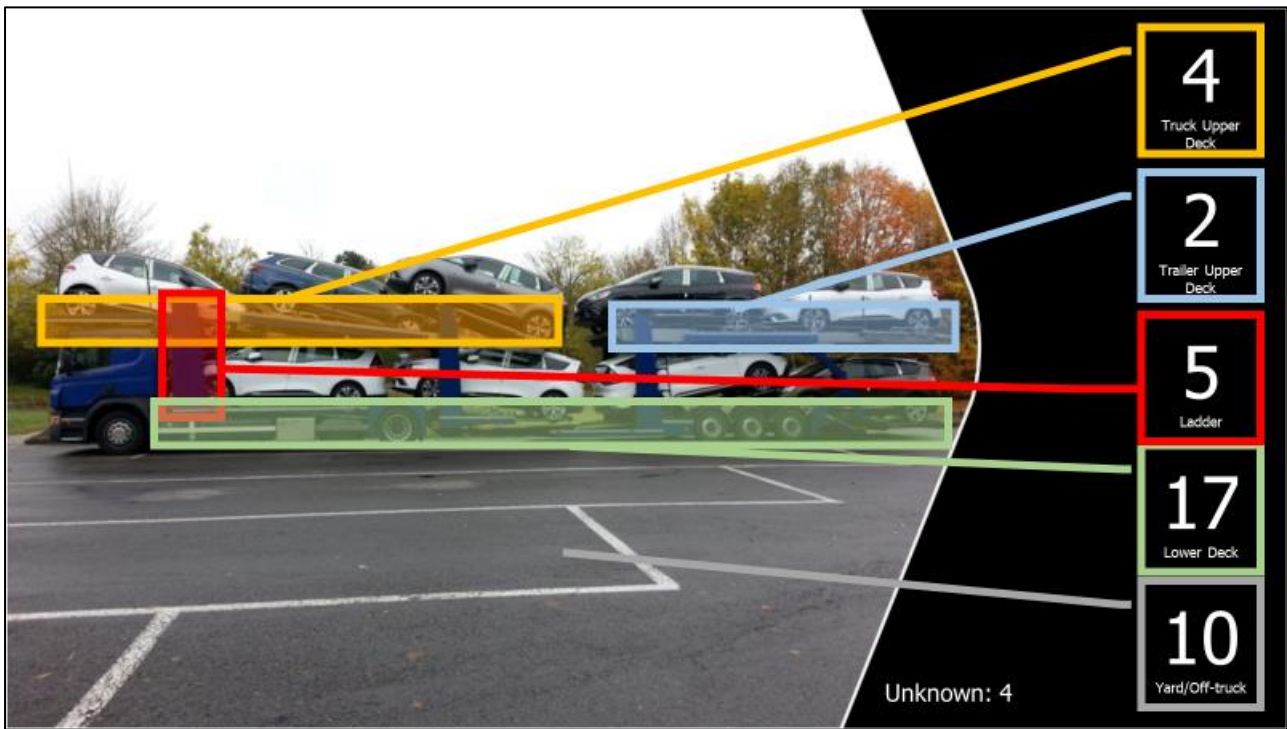
Fig. 3 – The areas where STFOs occurred

STFOs are particularly common because they can occur anywhere on the truck, and even while working or walking in the yard as shown in Fig. 3 below. A large proportion of these incidents occur on the truck itself due to the uneven surfaces, gaps, holes and loading material on the decks, but prevalent environmental conditions (e.g. ice and snow) can also lead to such events occurring in the yard.

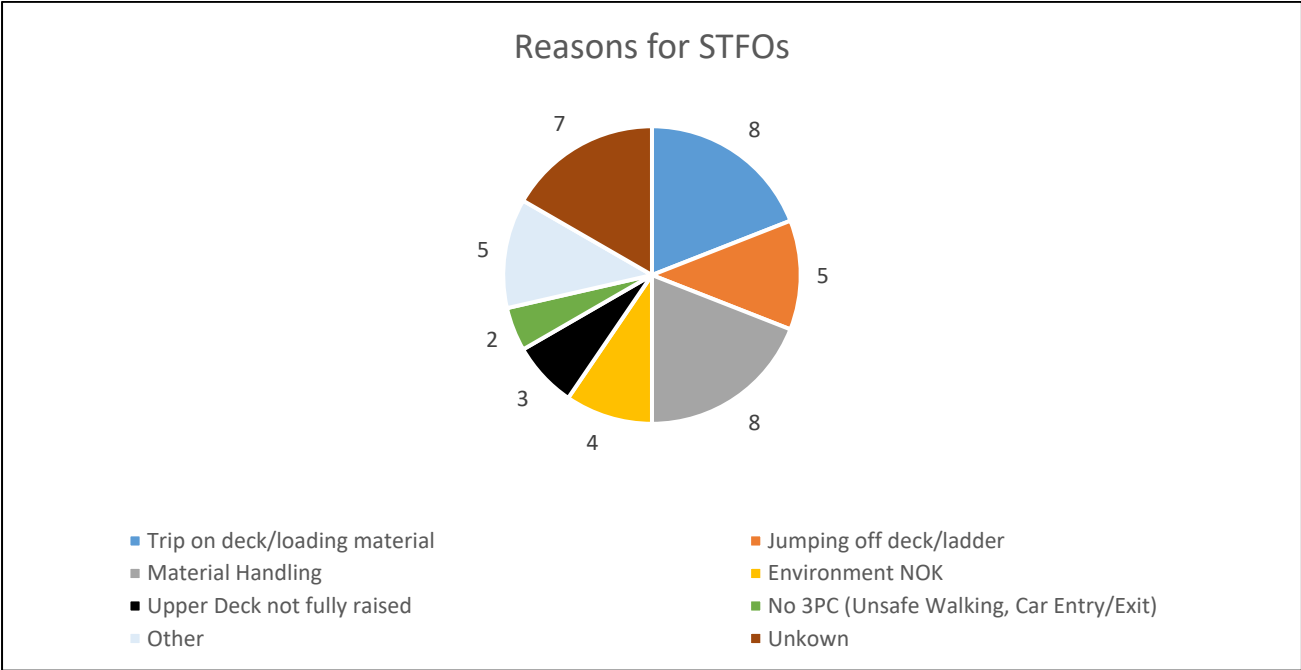
Fig. 4 – The causal factors leading to STFOs

One of the main reasons for STFOs is tripping on decks – in holes, on loading material (e.g. chocks/lashes), gaps – or even between decks. Another causal factor is improper material handling (e.g. handling chocks/lashes and stumbling forward, placing loading ramps incorrectly). These two errors were clear factors in 16 of the 42 (38%) reported incidents.

Drivers working in a rush e.g. jumping off decks and not raising the upper deck fully while working on the lower decks also resulted in several STFOs in 2019. The category “Other” also contains examples of driver indiscipline, such as the use of a mobile phone while walking or missing out steps on ladders while climbing. In total, at least 15 of the 42 (36%) incidents can be attributed to drivers not following safe loading guidelines.

Lastly, as mentioned earlier, poor conditions in the yard (e.g. ice, slippery surfaces or debris lying around) can also lead to STFO incidents. This was the case in 4 (10%) reported incidents from 2019.

From the data reported, nearly all the STFO incidents can be linked to non-compliance with the ECG Guidelines - Safe Loading Process. Therefore the best way to reduce STFO incidents is for truck operators to train, audit and supervise drivers in accordance with the ECG Guidelines - Safe Loading Process (which provides clear key-points on how to minimize the risk of such incidents). Involving trailer manufacturers in the training process is also to be encouraged.

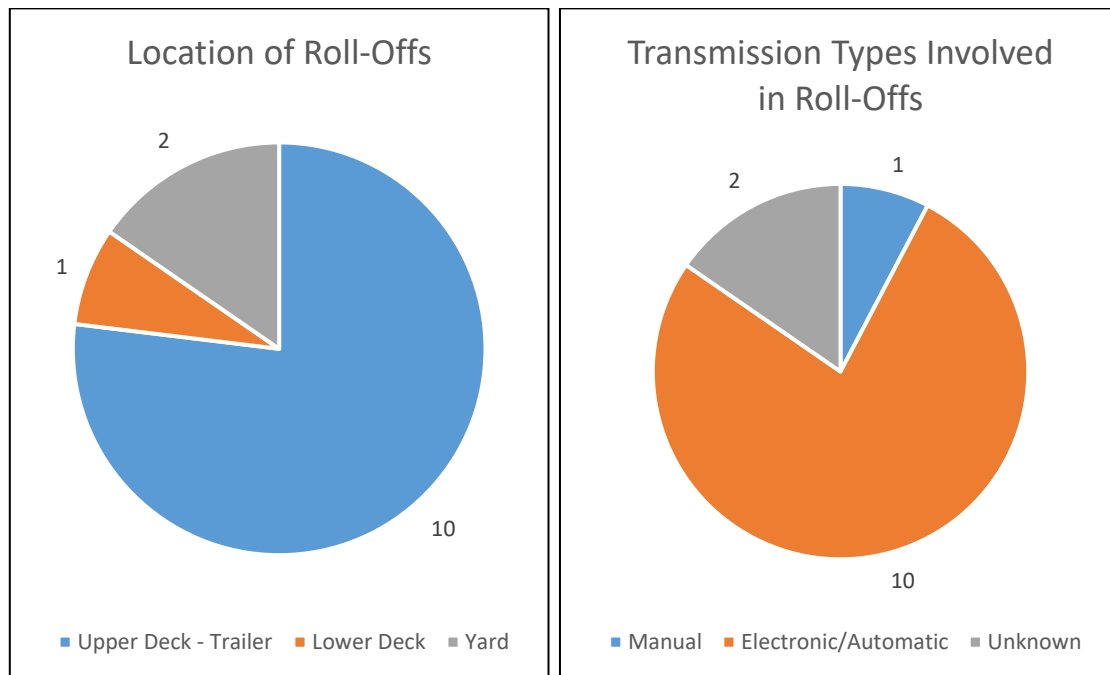
Fig. 6 – Trends in roll-off incidents: location and transmission

1. In 2019, 10 of the 13 (77%) cars involved in roll-offs were Electronic Parking Brake (EPB) type cars; this is similar to data from 2018 where 5 of 6 reported roll-offs (83%) involved EPB cars.
2. In 2019, it was reported that 10 of the 13 cars rolled-off from the trailer upper deck (77%); this too is similar to data from 2018, when 5 of 6 reported roll-offs (83%) also originated from the trailer upper deck.

The way that EPBs work may offer an indication as to why such systems may lead to an increase in the number of roll-offs.

Previously, drivers parking their cars on trucks had to perform two separate actions to ensure their cars were secure: namely, putting the gear in “Park” position (or 1st position for manual systems) AND physically applying a hand-brake or a foot-brake. With the introduction of EPBs, however, drivers know that putting the gear in “Park” engages the electronic brake automatically, meaning they often do one action less. The problem with this is that if the gear is not actually properly applied (e.g. left on “Reverse” position instead of “Parking” because the driver may not be paying attention), this means that neither axle is locked, and the car is at risk of rolling-off. This would not have been a problem before because, in all likelihood, if the gear was not properly engaged, drivers would have in any case pulled on a traditional hand brake, securing the rear axle.

The 1st position on the trailer deck is one of the highest risk positions for loading, on a par, or just behind the 1st position on the truck upper deck. In this position, the decks and cars need to be positioned just right: if a car or deck is too far ahead, it may lead to problems during transport while the truck is turning and manoeuvring; if the deck is too far back, there may not be enough room to load the optimum/desired number of cars, with the required clearances. It may be difficult to prepare the deck correctly, without actually having a loaded car on this position.

This means that cars loaded in position 1 on the trailer are more likely to be adjusted after being loaded than perhaps in any other position. This may explain why roll-offs are relatively higher from this position, but as with the EPB question, **this point also warrants further investigation.**

As a concluding remark, it should be highlighted that all roll-offs reported can be linked to non-compliance with the ECG Guidelines - Safe Loading Process. As with STFOs, therefore, the risk of roll-offs may be mitigated by training, auditing and supervising drivers in accordance with the ECG Guidelines - Safe Loading Process.

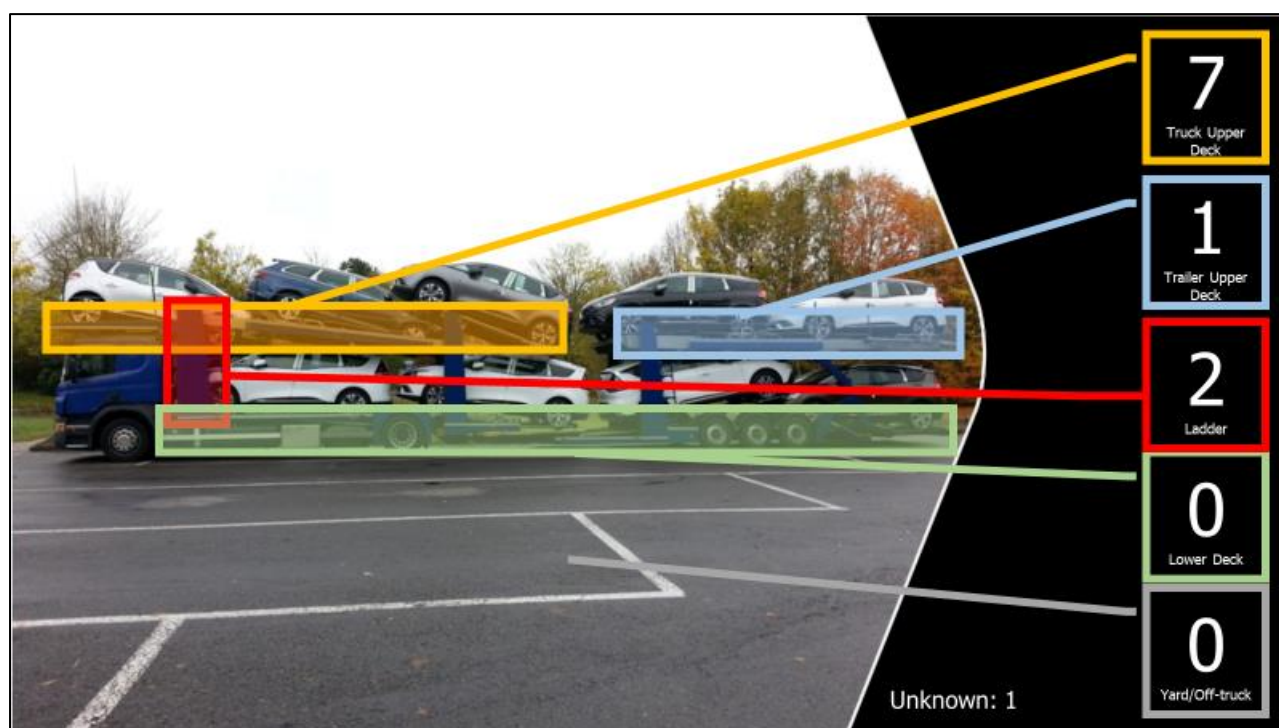
Fig. 7 – The areas where falls from height occurred from

Given the nature of the incident, falls from height occur primarily from the upper deck or from side ladders. Of the 11 reported fall incidents in 2019, 7 occurred from the Truck Upper Deck, 1 from the Trailer Upper Deck and 2 from the side ladders as shown in Fig. 7 below.

Falls from height can be fatal or lead to unrecoverable injuries. Fortunately, none of the falls from height reported for 2019 led to unrecoverable or fatal injuries (however 1 fall from height from 2018 did result in an unrecoverable injury to the driver). Nevertheless, falls from height are a real safety concern for the industry and will remain so until significant breakthroughs which eliminate the height risks in both compounds and at retailers.

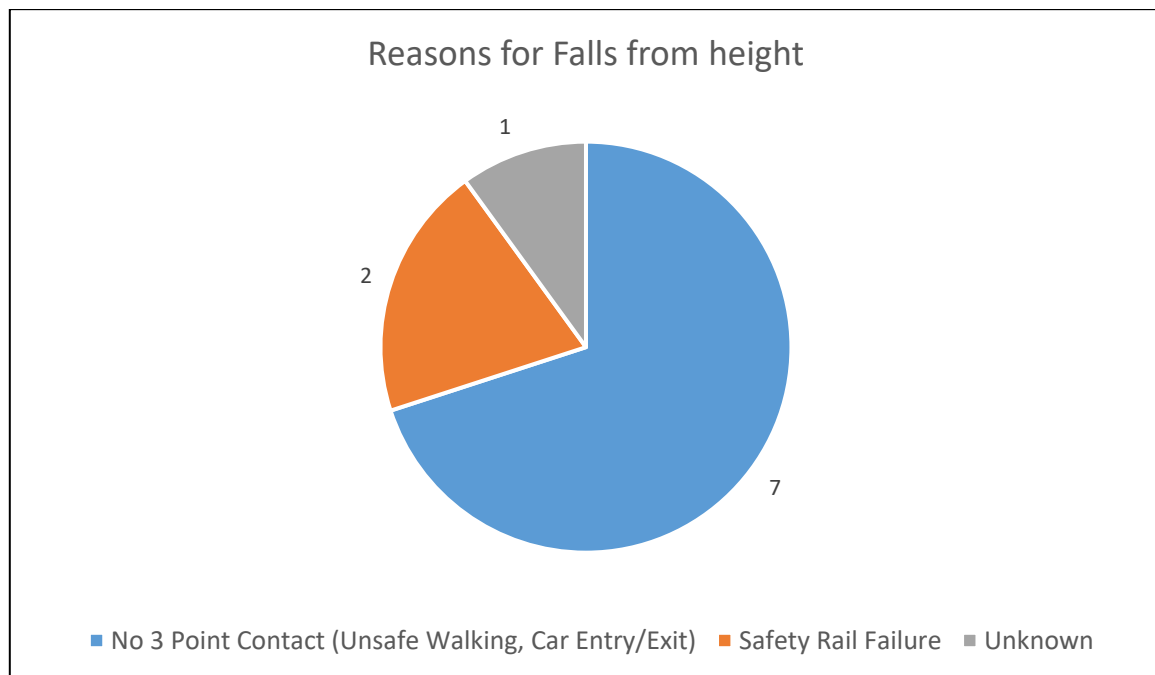
Fig. 8 – The reasons contributing to falls from height

1. Unsafe driver movement (lack of 3PC while walking, or when entering/exiting cars)
2. Structural failure (of safety rail wires or poles)

7 incidents reported in 2019 indicate a lack of 3PC as the causal factor for falls from height (1 such case was also reported in 2018):

1. In 4 of these incidents, the drivers were walking on the deck when they stumbled and fell through a gap in the safety rails;
2. In the remaining 3, the drivers were exiting cars on the upper deck when they stumbled backwards or sideways through a gap in the upper deck;

Structural failure, as mentioned above, is another contributory factor towards falls from height. Safety rails have been known to fail, truck drivers sometimes remove safety rails to load wider/larger cars, and some positions on the truck upper deck may not be covered by safety rails at all to allow deck adjustment. Indeed, of the 4 falls from height incidents reported in 2018, 3 (75%) were linked

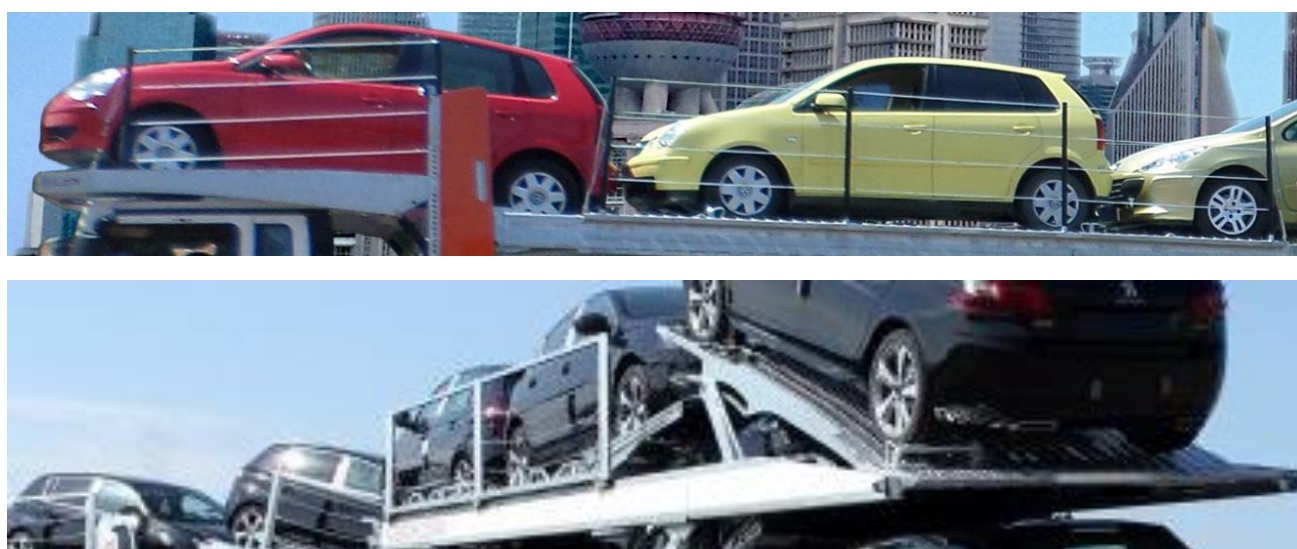
Fig. 9 – “Continuous wire” safety rail (top) vs 4 individual wire rail (bottom)

By contrast, in 2019, only 2 of the 11 (18%) reported cases are related to safety rail failures. In both cases, the safety cable snapped after a driver leant on it while moving around a car on the upper deck. **Notably, both safety rail failures in 2019 involved a “continuous-loop” type wire (instead of a safety rail with 4 individual wires).**

1. **The maintenance records of each pole** including dates, and whether or not it was maintained by a trailer-manufacturer approved workshop
2. **The design of the poles and cables** with a particular focus on the weight and load restrictions
