# Making the industry safer -Reducing accidents in FVL

# 2020 incidents & analysis

**JUNE 2021**

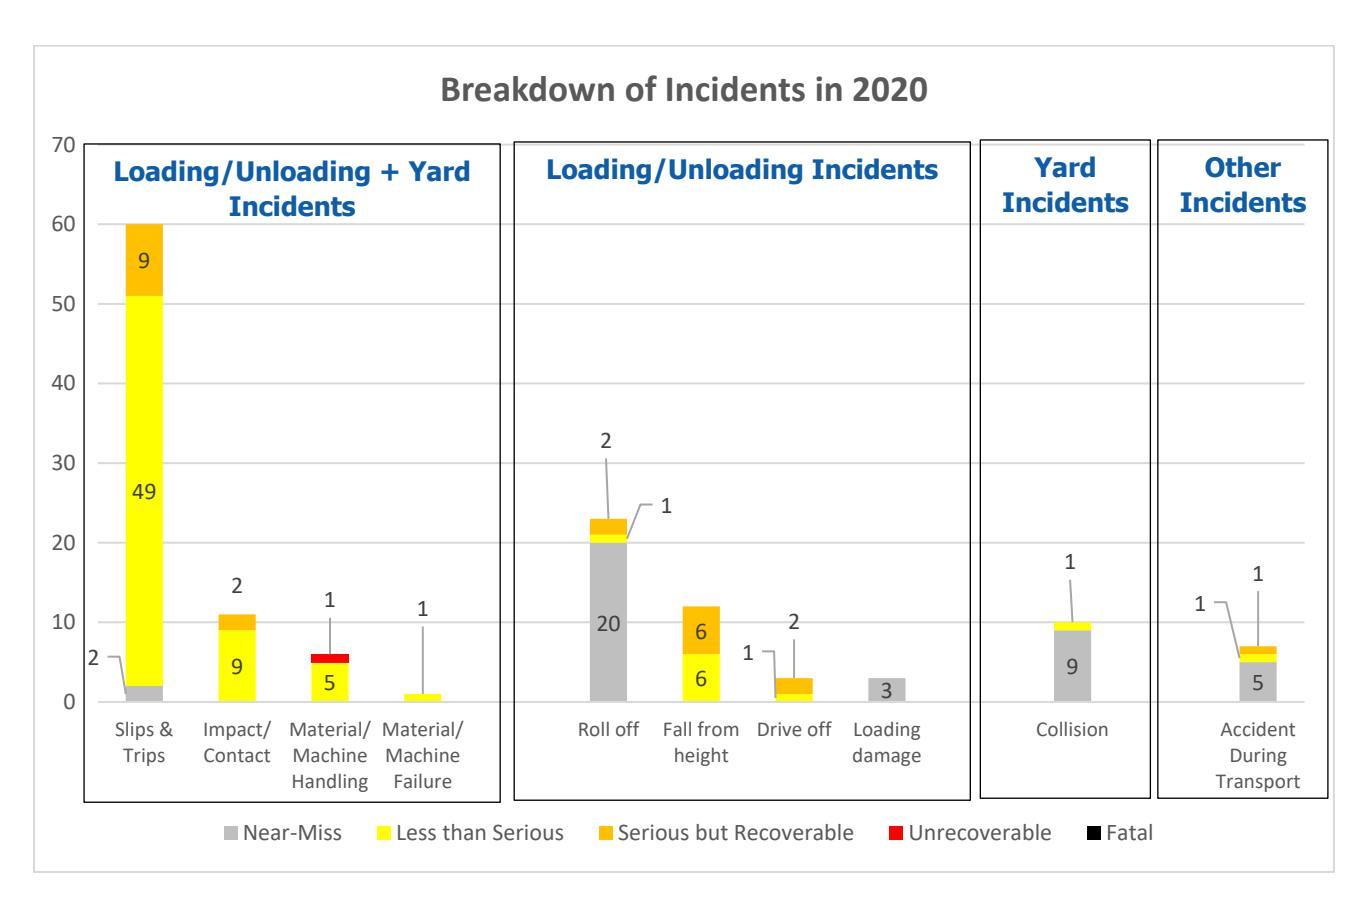
Fig. 1 – Incidents' breakdown for 2020

136 truck loading/unloading incidents have been analysed for 2020, as shown in Fig. 1 below.

The most common incidents reported for 2020 are Slips & Trips (S&Ts). S&Ts occurred both during loading/unloading and in yard operations. Of the 60 S&Ts in 2020, 15% of accidents resulted in Recoverable but Serious injuries, whilst 82% led to injuries that were Less than Serious. The proportion of serious injuries makes S&Ts the most serious incident category for the incidents reported in 2020. This was also the case in 2019.

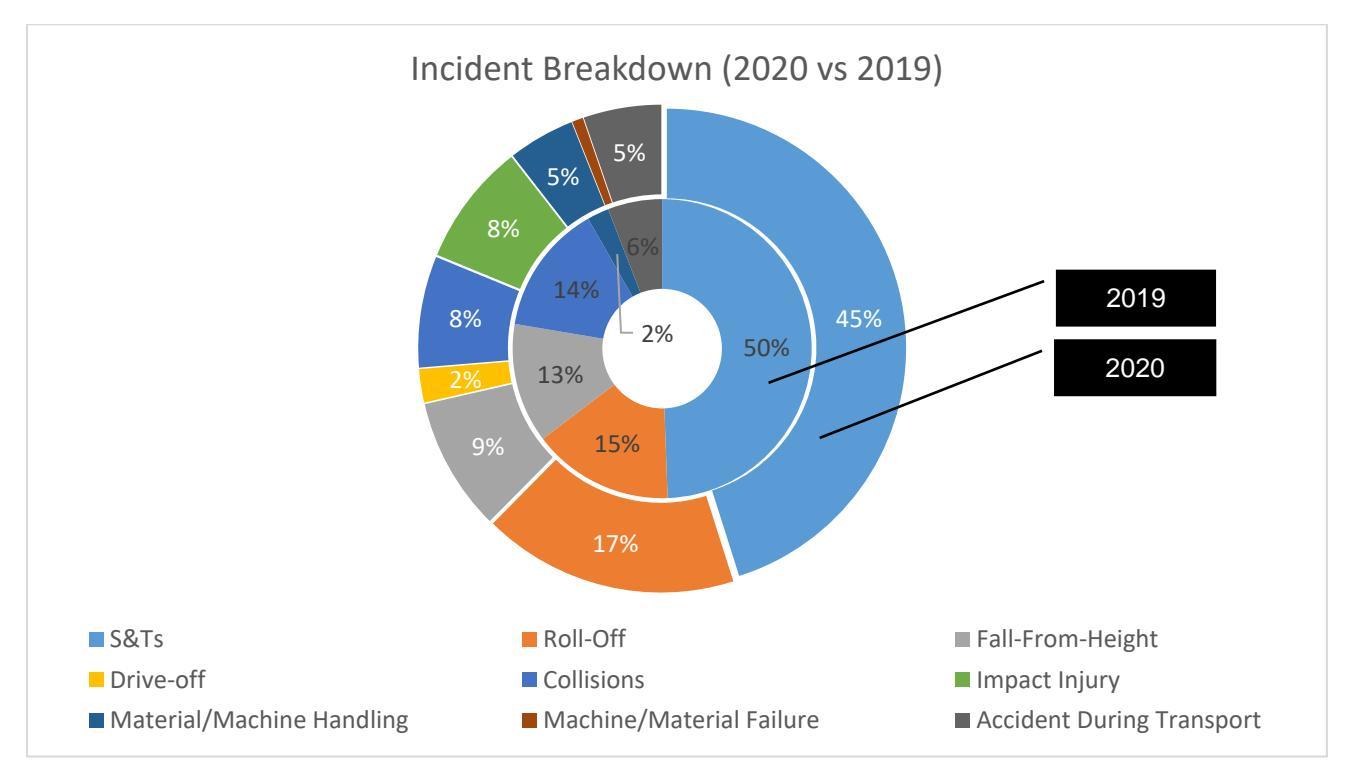
Fig. 2a – Incident breakdown comparison for 2019 & 2020.

Fig. 2a shows similar key trends between 2019 and 2020 reported incident data.

Slip & Trips *do* constitute the majority of the reported incidents in the FVL industry (~ 45-50%), followed by roll-offs (~15%). The proportion of fall from height incidents also shows a similar trend (~9-13%). The data also indicates that approximately 2-5% of FVL industry incidents are car-man collisions.

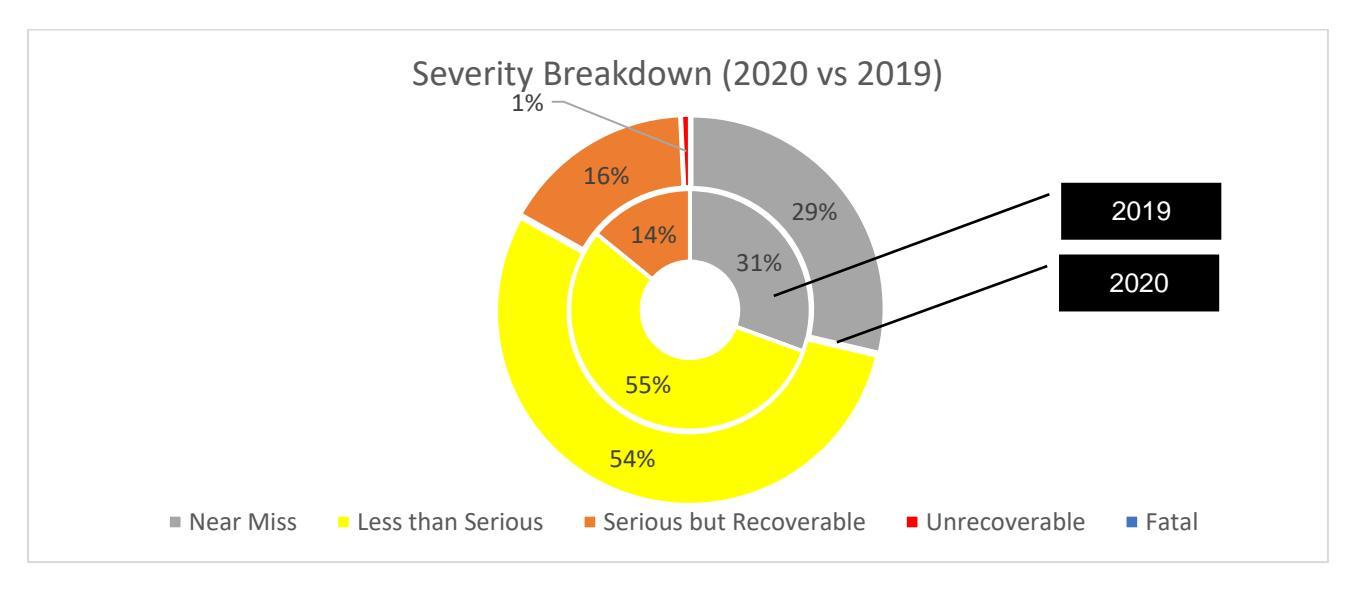
Fig. 2b – Incident severity comparison for 2019 & 2020

Fig. 2b clearly shows a similar breakdown in severity of reported accidents in 2019 and 2020. One key point is that there still appears to be reluctance to report more serious accidents which lead to fatalities or unrecoverable injuries.

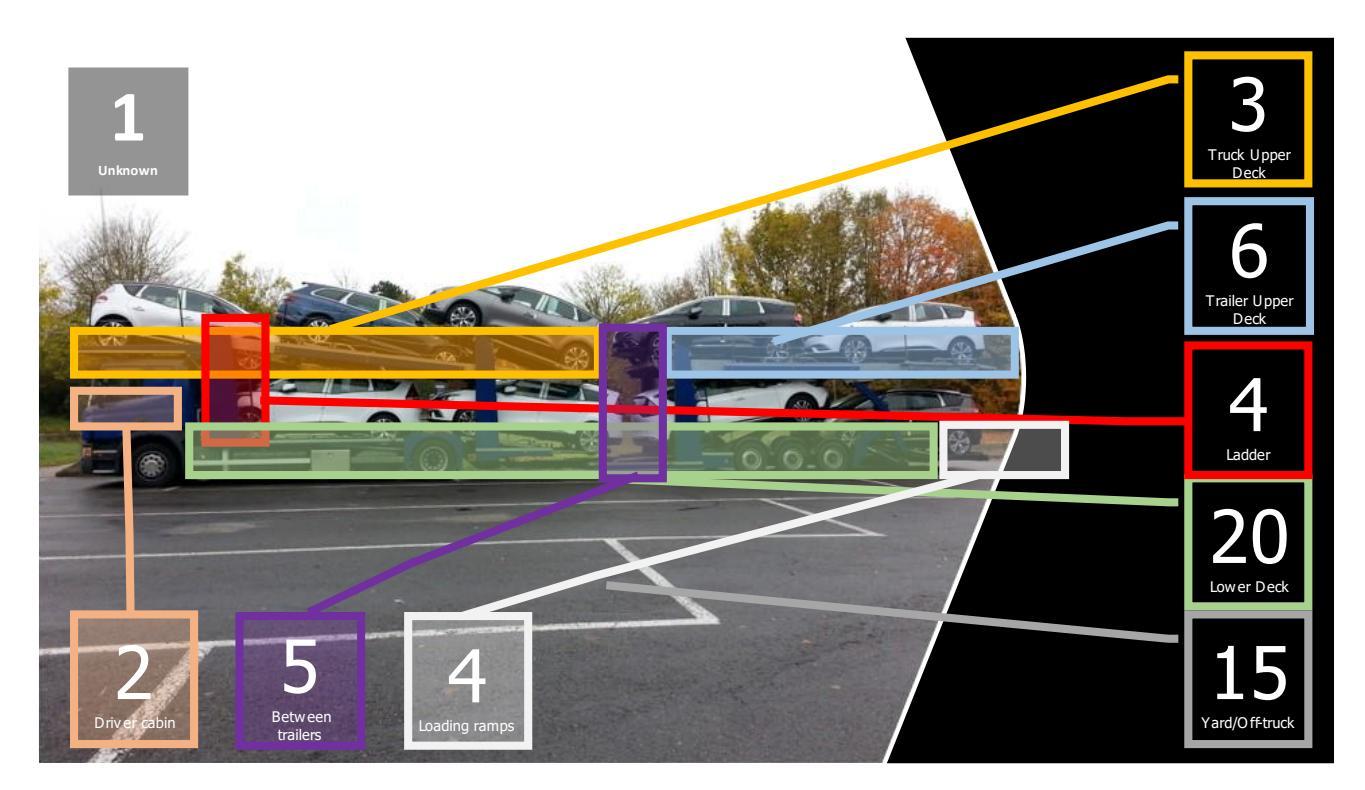
Fig. 3 – The areas where S&Ts occurred. 1 S&T occurred in an unknown area.

S&Ts are particularly common because they can occur anywhere on the truck, and even while working or walking in the yard as shown below. A large proportion of these incidents occur on the truck itself due the uneven surfaces, gaps, holes and loading material stored at walking level, but prevalent environment conditions can also lead to such events occurring in the yard.

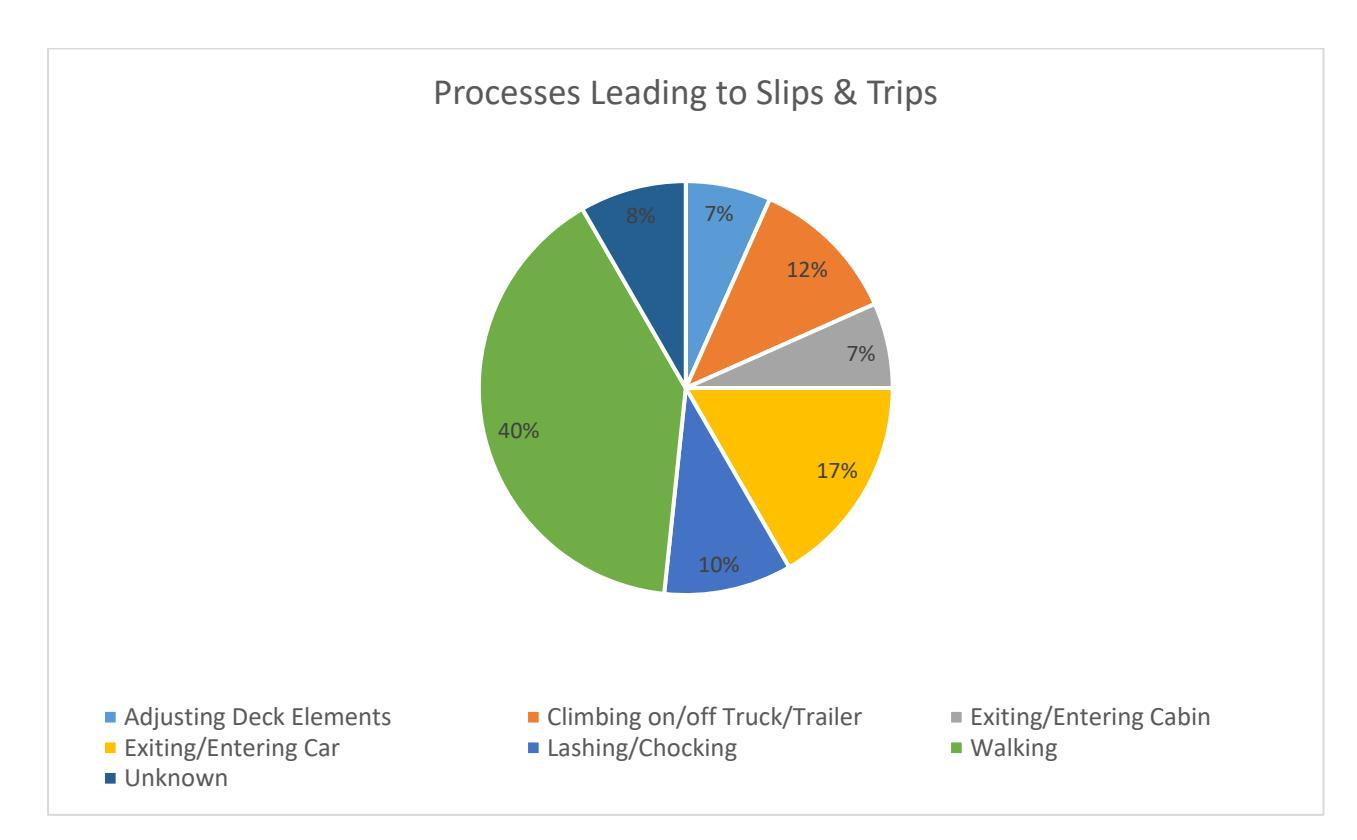
Fig. 4 – The causal factors leading to S&Ts

A large number of the S&Ts occur when drivers are walking. 13% of the walking-related incidents occur in the yard due to uneven or slippery surfaces. The remaining 27% occur on trucks – resulting from drivers tripping in holes and walking over gaps whilst not concentrating.

Not concentrating whilst exiting/entering cars and not applying 3-point contacts contributed to another 17% of S&Ts in 2020.

Unsafe lashing/chocking (e.g. stepping backwards whilst getting up/not applying 3 points to contact) caused 10% of S&Ts. Climbing on/off the trailer unsafely led to 12% of S&Ts and exiting the cabin unsafely (w/o 3 points of contact, w/o checking environment) caused 7% of S&T incidents.

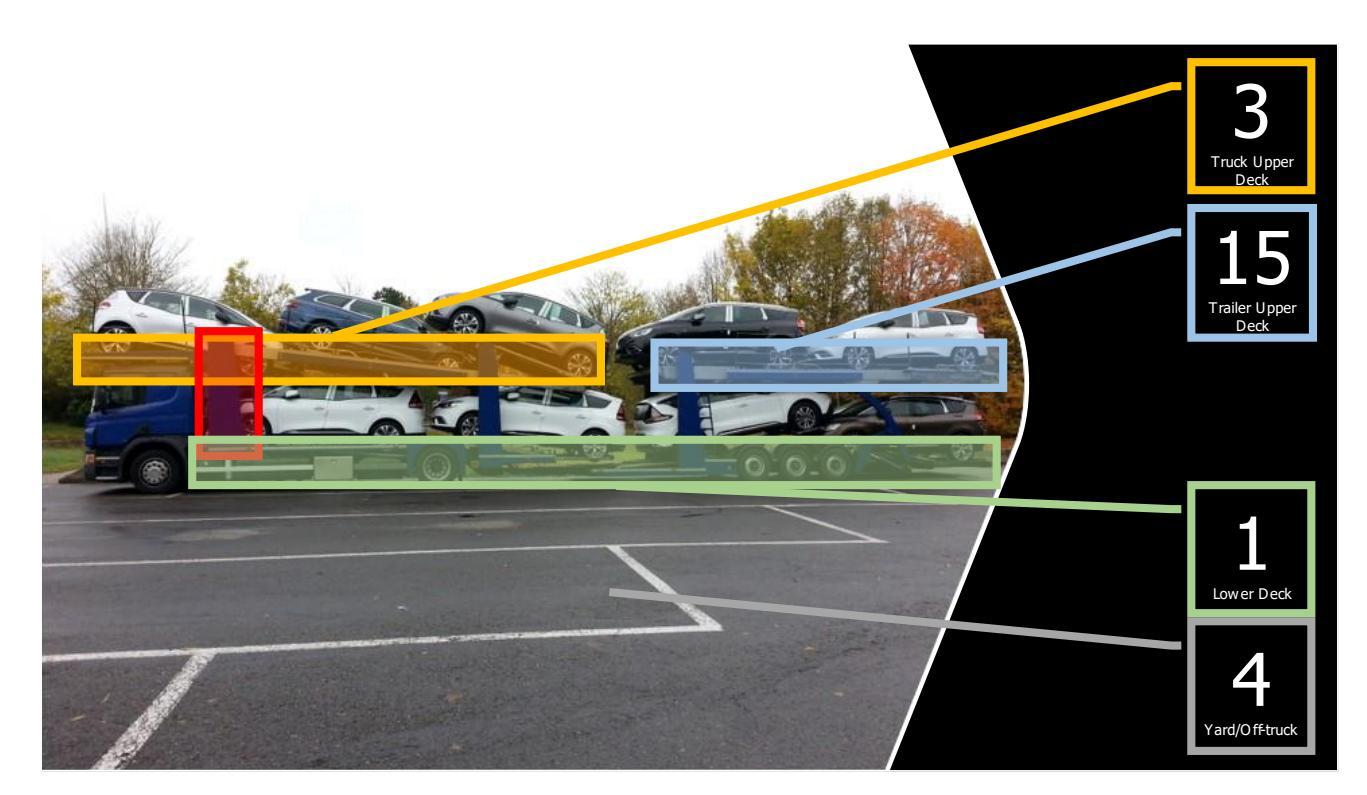
Fig. 5 – The areas where roll-offs occurred from

In 2019, it was also reported that 10 of the 13 cars rolled-off from the trailer upper deck (77%). Thus, the report last year indicated that the complexity of loading in this position might be another contributory factor towards roll-off incidents. The incident data for 2020 appears to confirm this suggestion: 65% of roll-offs in 2020 occurred from the trailer upper deck.

It is important to reiterate that the industry should investigate the true impact of both EPBs and loading positions on roll-off accidents. This, however, is only possible through concise incident reporting. We therefore ask all ECG Members to include these (and all other relevant) details when they upload incident reports on the ECG database.

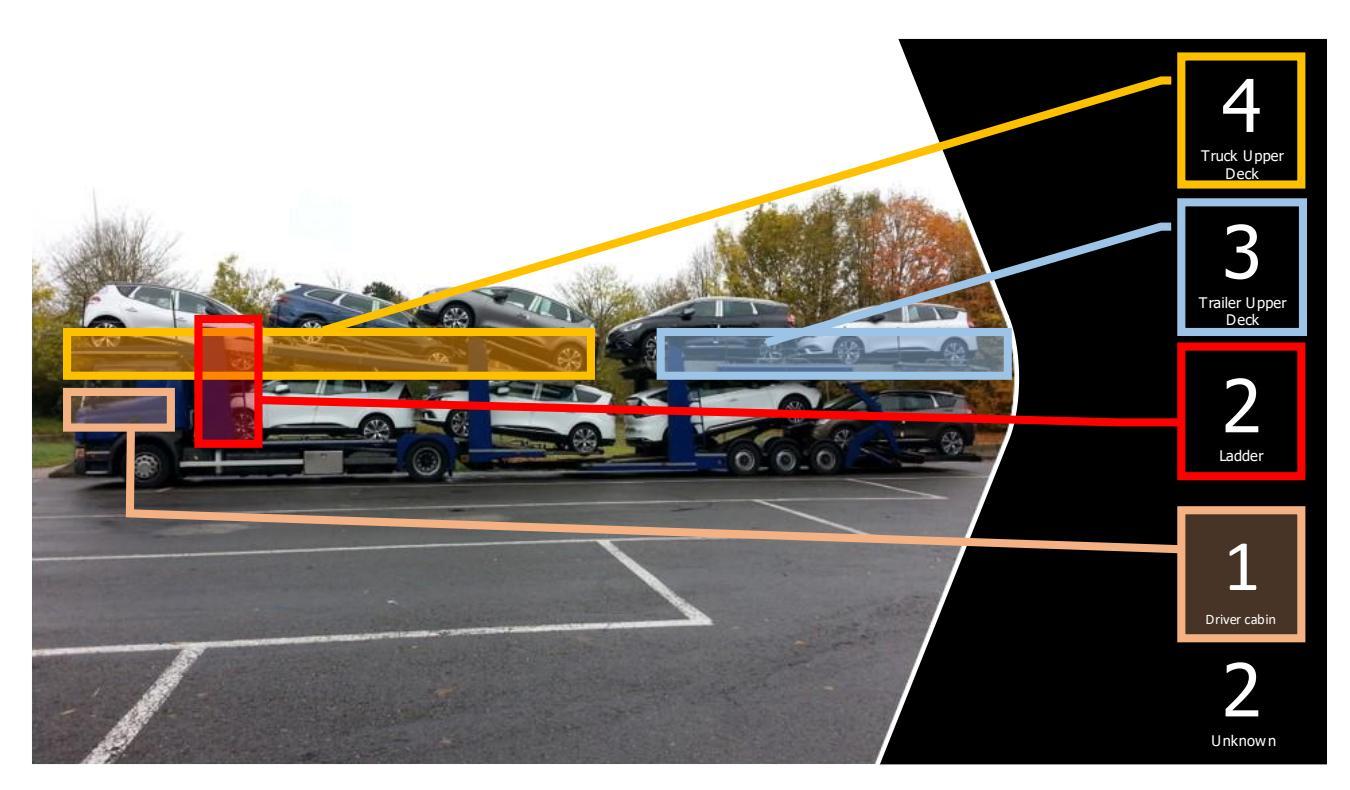
Fig. 6 – The areas where falls from height occurred from

Given the nature of the incident, falls-from-height occur primarily from the upper deck or from side ladders. Of the 12 reported fall incidents in 2020, 4 occurred from the Truck Upper Deck, 3 from the Trailer Upper Deck and 2 from the side ladders. 1 fall-from-height occurred from the driver cabin, where the driver fainted and fell out, resulting in Less than Serious injuries.
