Visual Inspection Guidelines

SEPTEMBER 2021

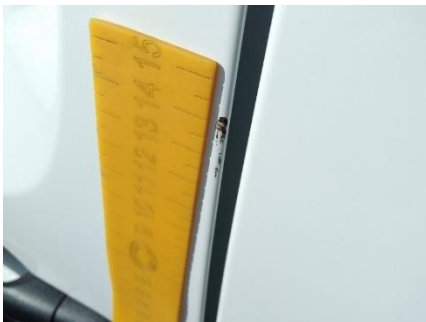
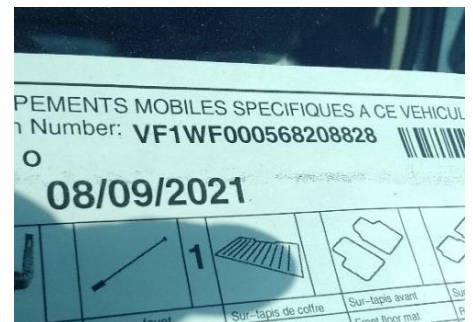
Any additional photograph that could assist the claims representative to better understand the type and extent/severity of the vehicle exception may be included.

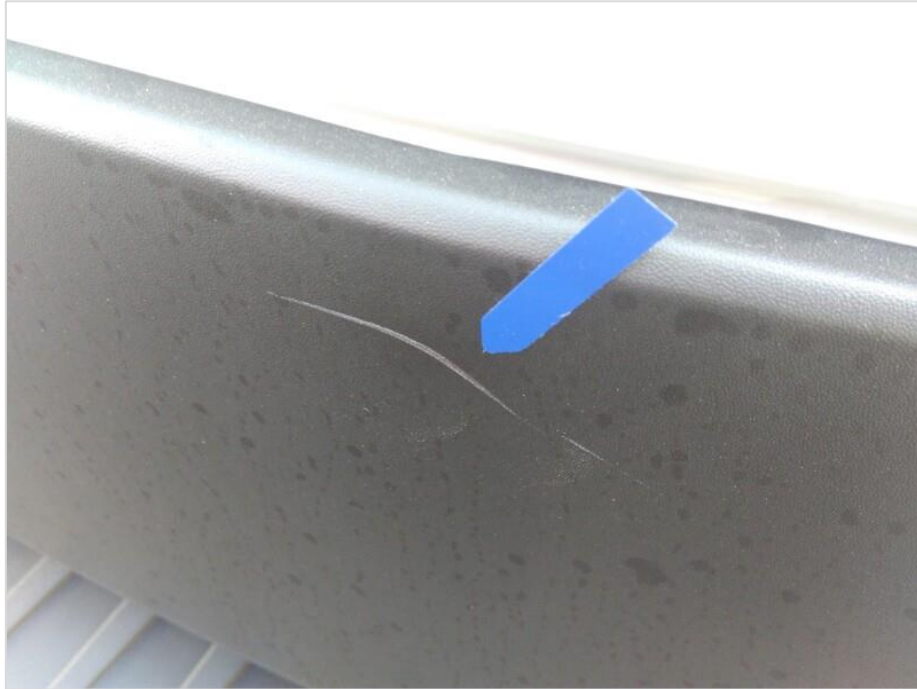
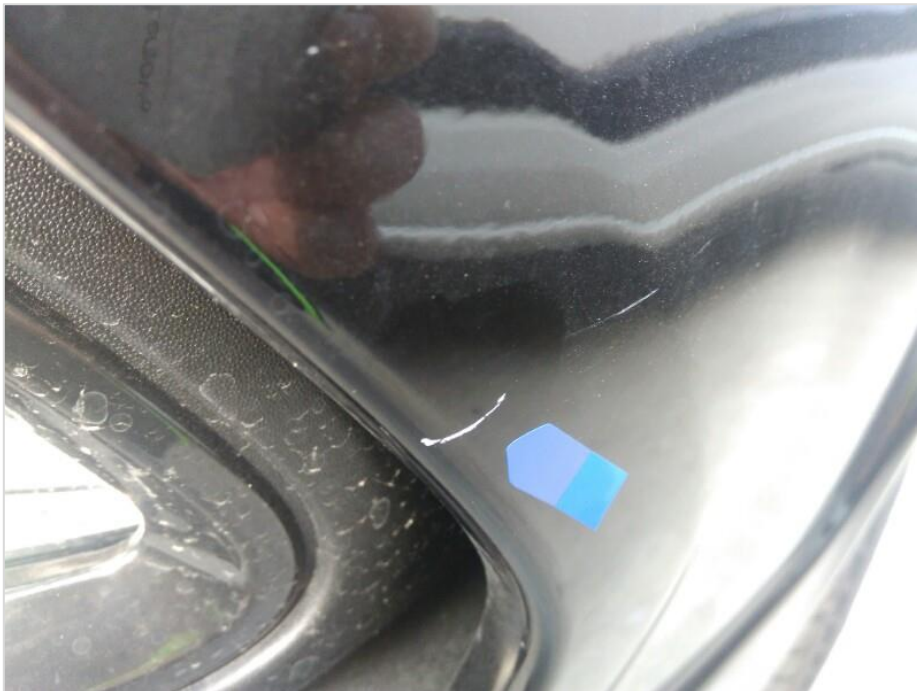
2. Damage with signs of forced entry

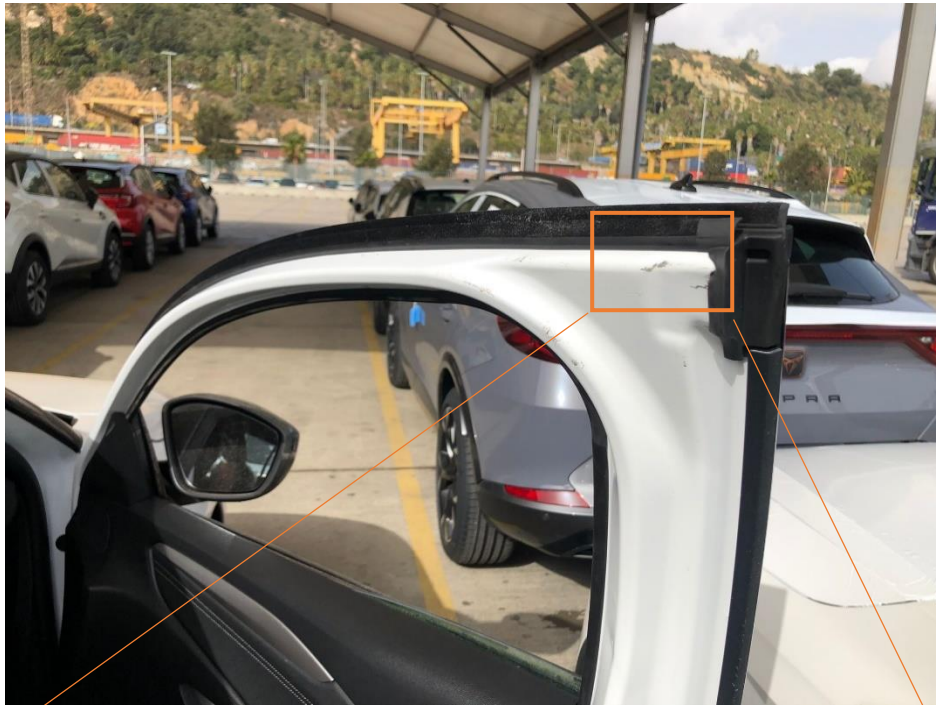
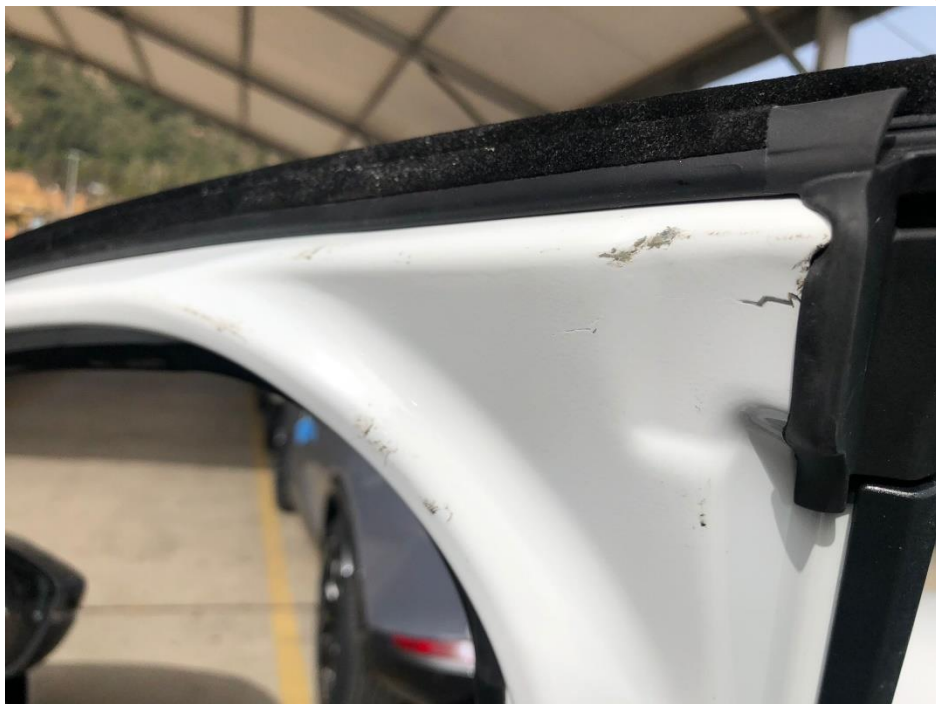
3. Exterior glass chipped, scratched or broken, caused by impact and not by stress (e.g. heat or incorrect fitment)

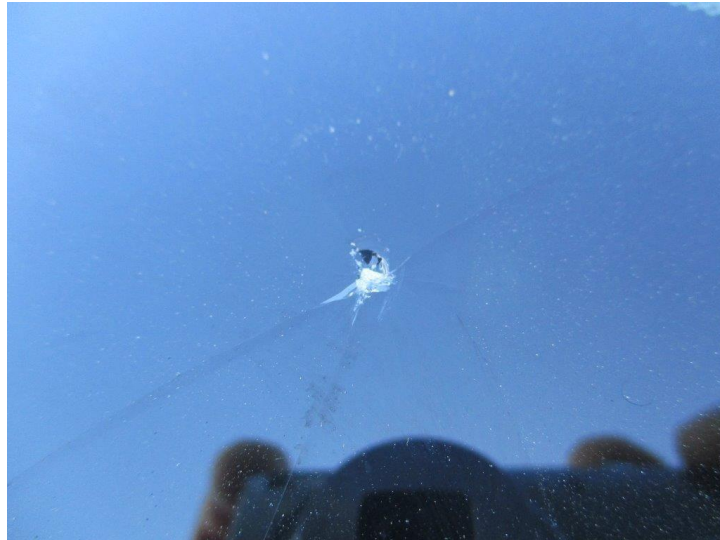
4. Damage underneath the Full Body Cover/transit film if the cover/film is physically damaged (e.g. broken, ripped, torn or affected otherwise) or if witness marks of impact are present

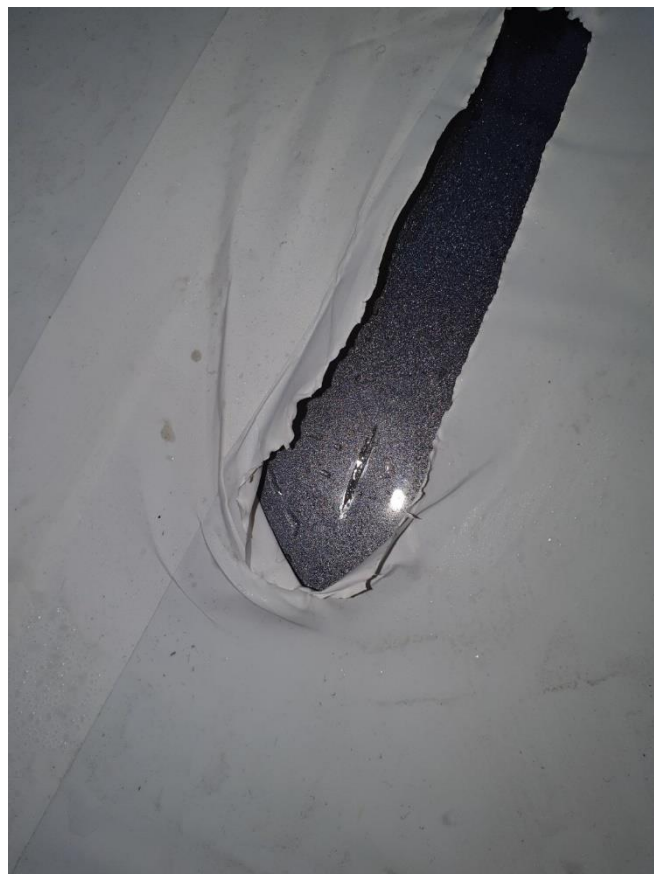
5. Damage or soiling of the driver's area of the interior and obvious vandalism or abuse to the interior (e.g. steering wheel, seat)

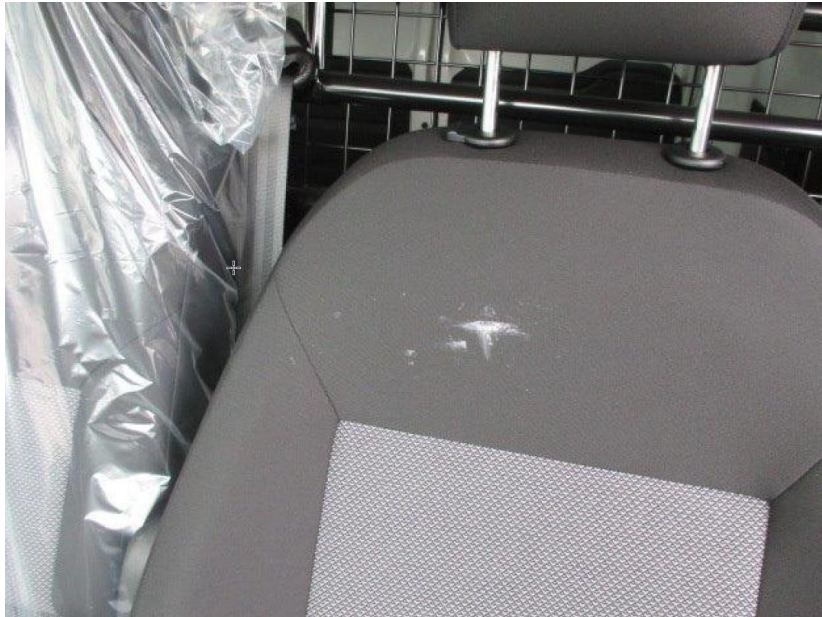
6. Tyre damage including cuts and gouges in the sidewalls or punctures/flats (except where a factory screw is the cause)

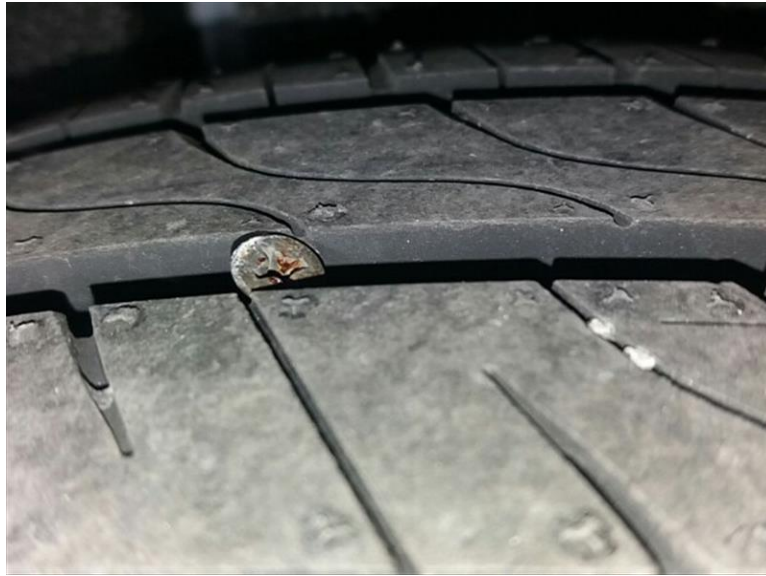
7. Wheel rim damage such as scratches on the outer rim with the exception of damage inside the rim (unless signs of carrier liability) and close to the wheel nuts or valve which are deemed to be damage caused during fitment

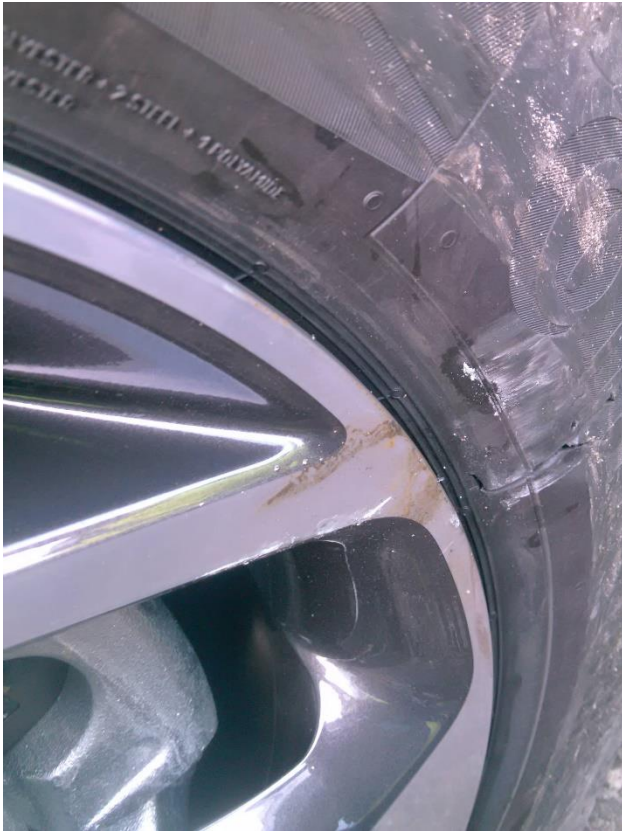
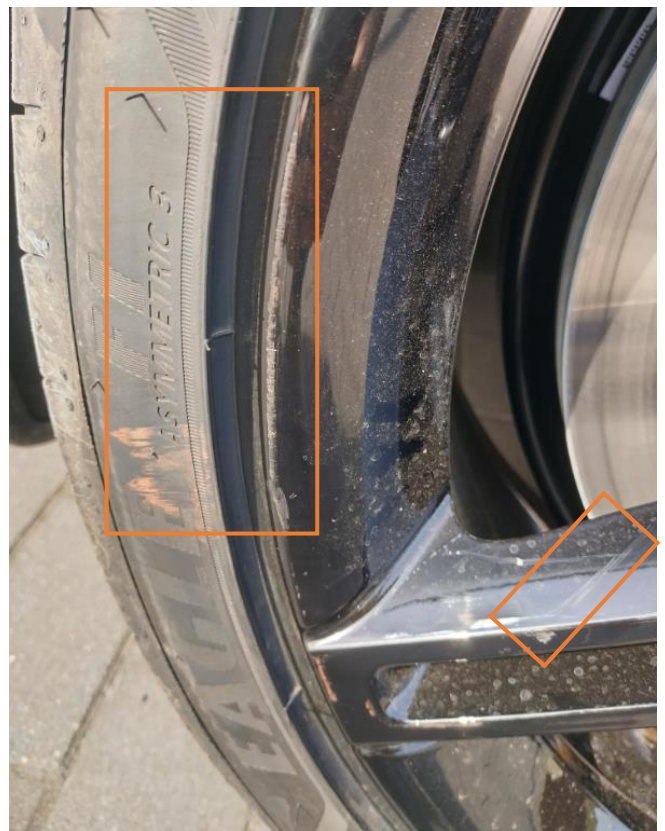
8. Damage to the underside of the front and rear bumper caused by impact (e.g. grounding out due to ramp angle)

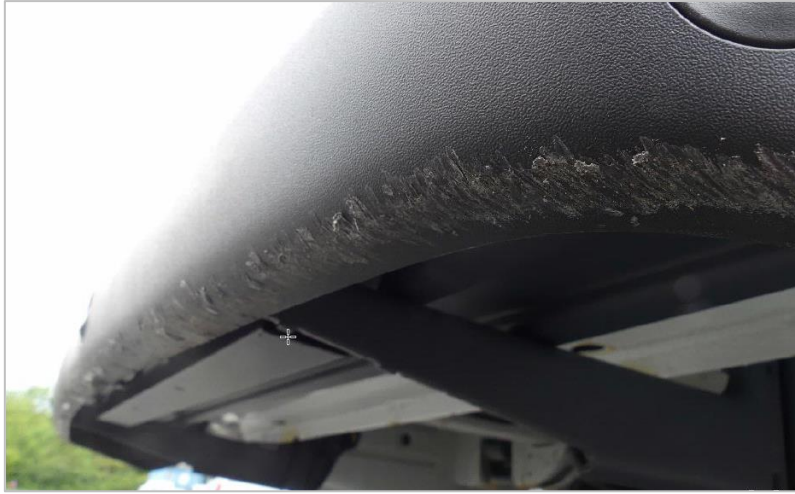
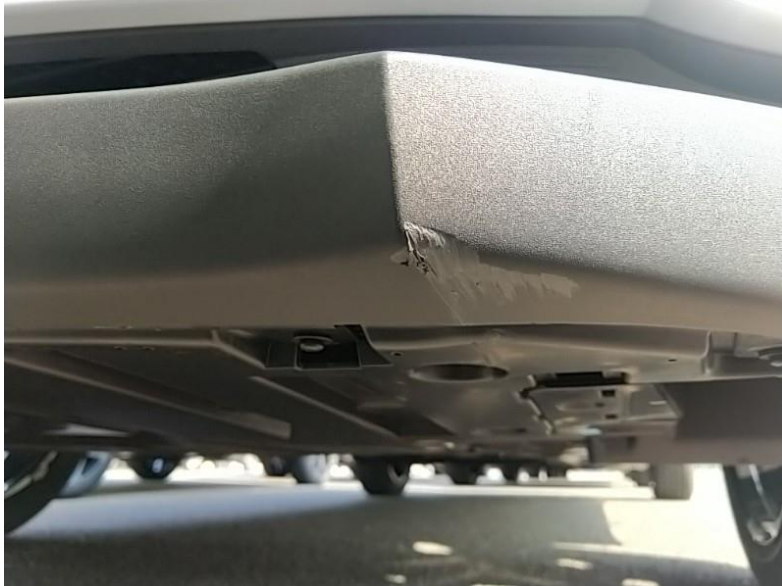
9. Interior damage due to water ingress caused by windows/doors/sunroof/boot lid not being properly closed is considered transportation damage, unless proven otherwise (e.g. mechanical and/or plant issues)

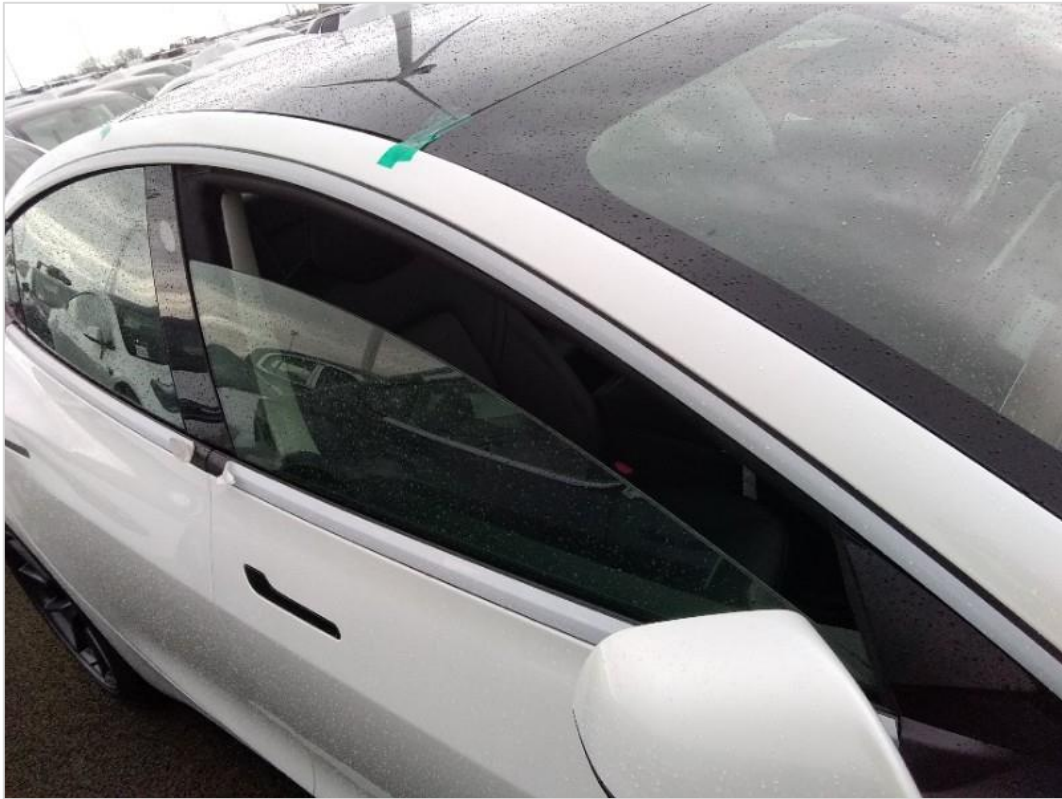
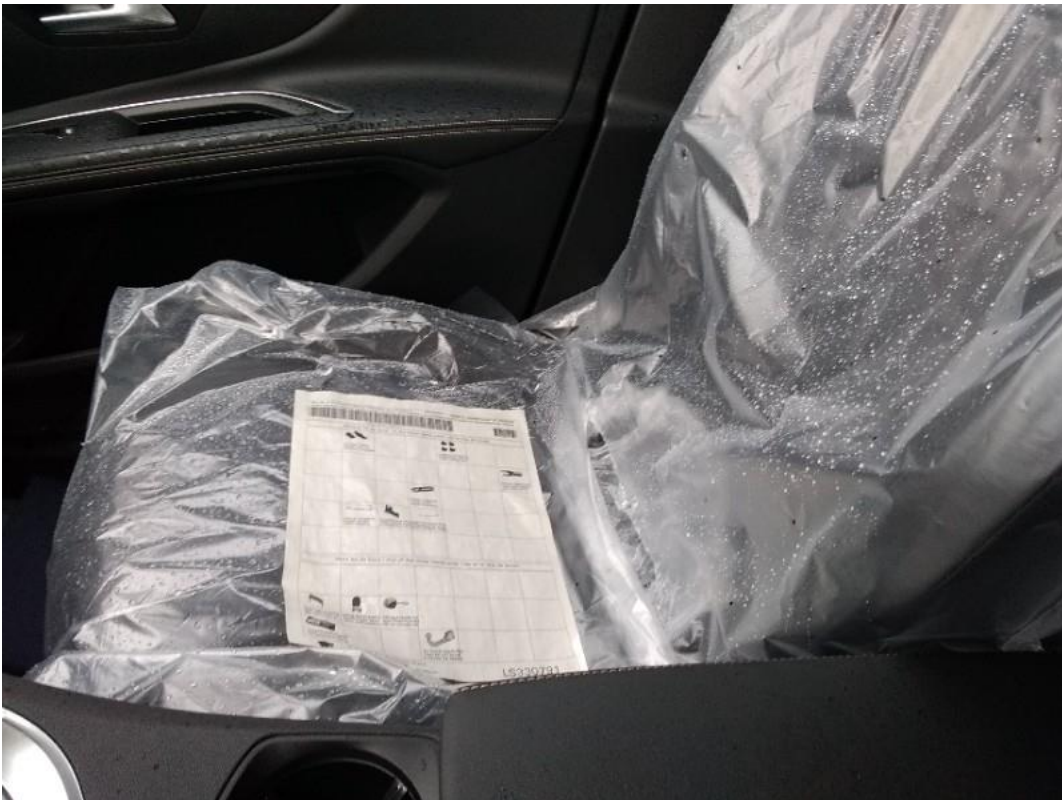
Typical examples of Warranty Defects

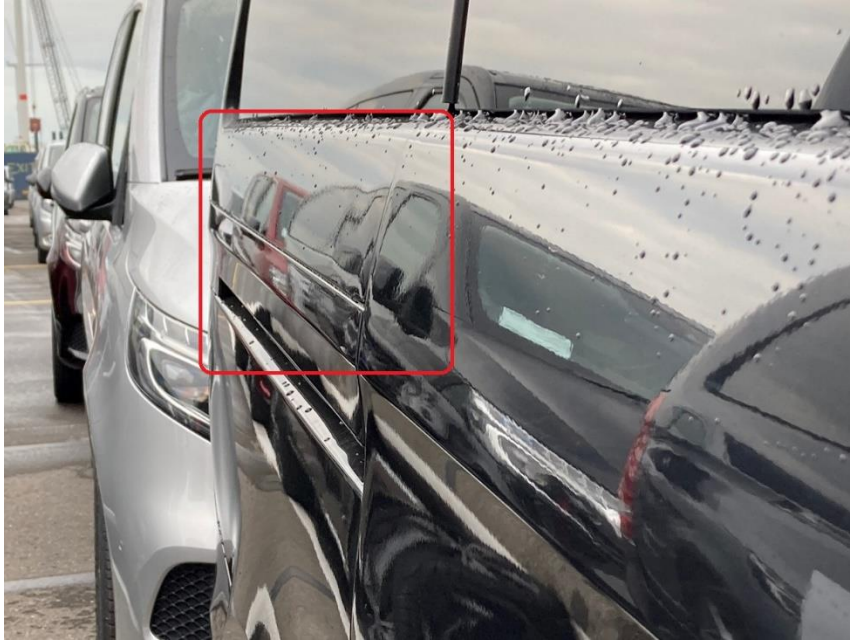
2. File, pressing, grinder or weld marks

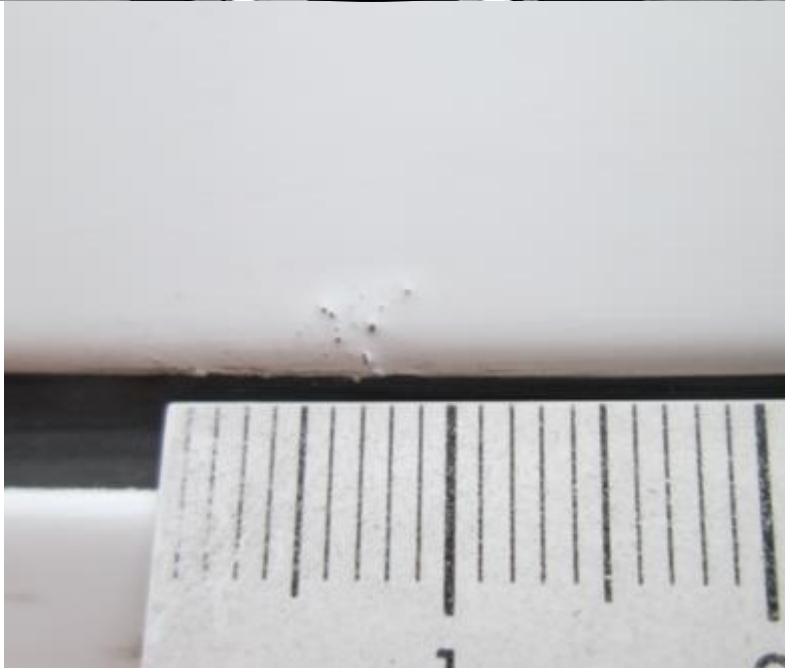
5. Minor chips, scratches or dents found under protective transit film or FBC unless there is evidence of impact (witness marks) or tampering to the film

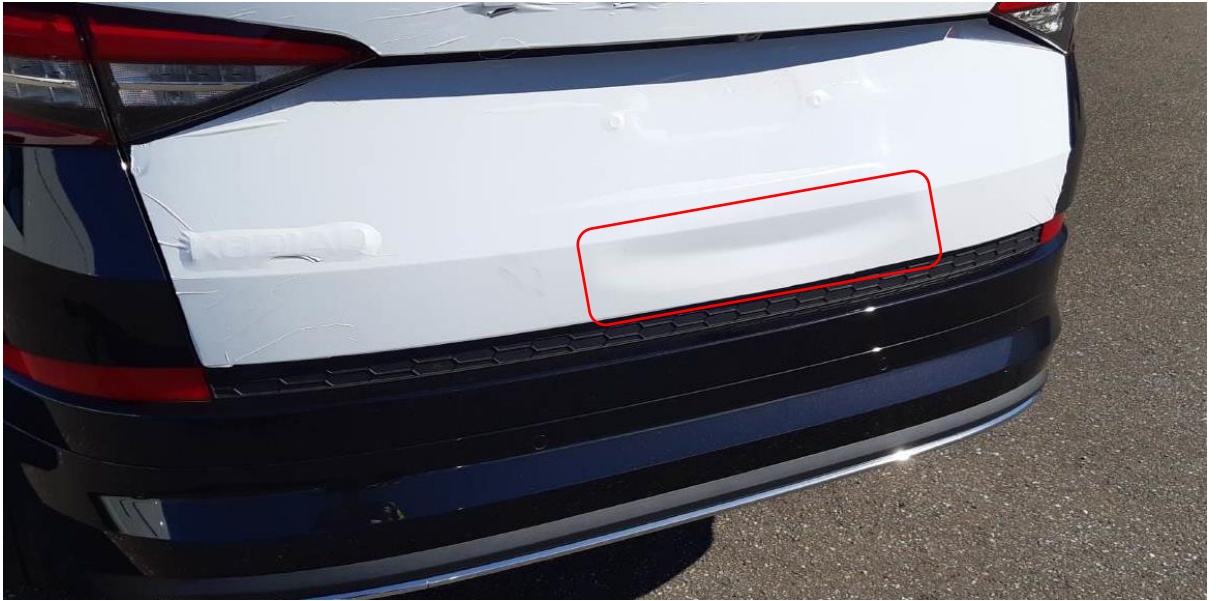
6. Stress cracks in glass (e.g. due to heat or incorrect fitting)

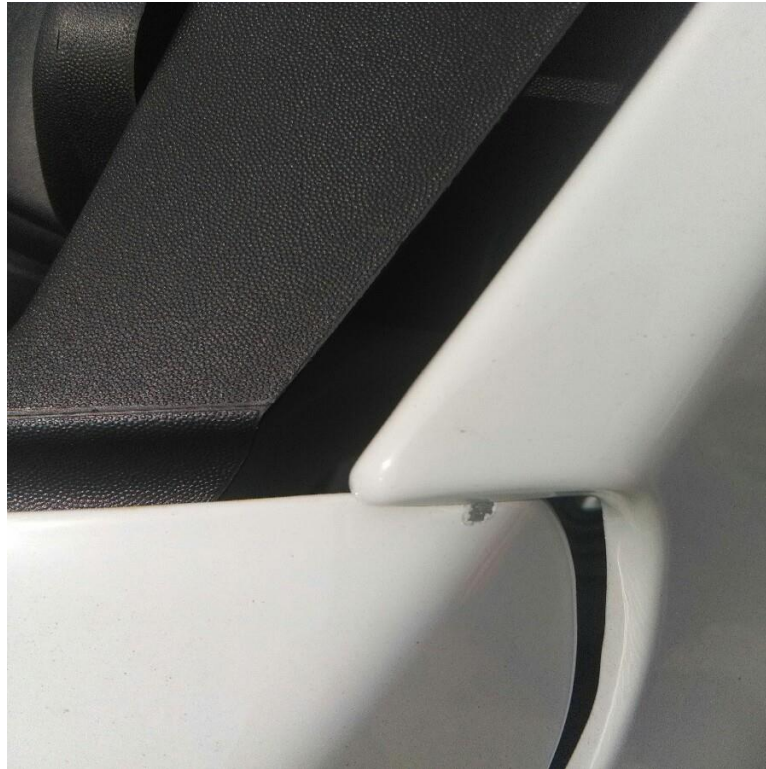
9. Bent parts caused by misalignment

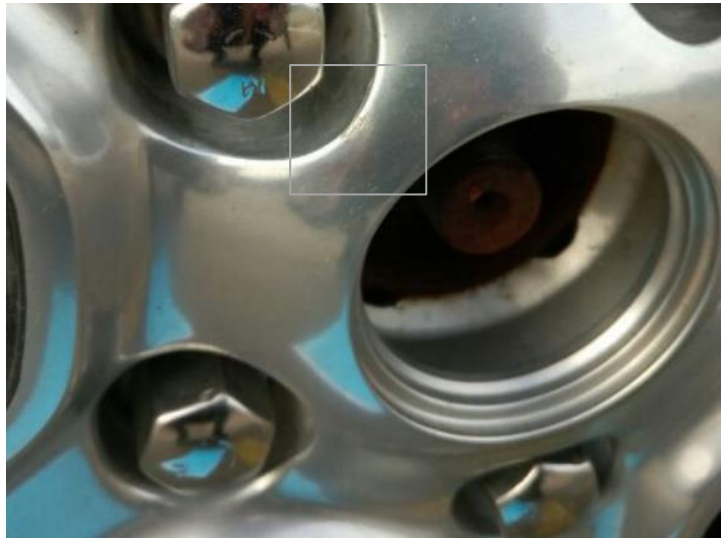
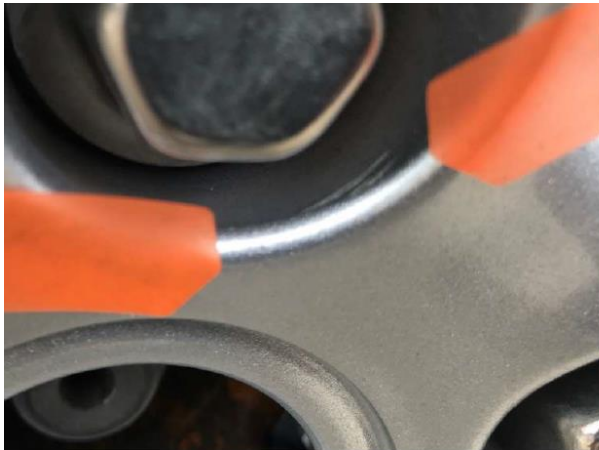
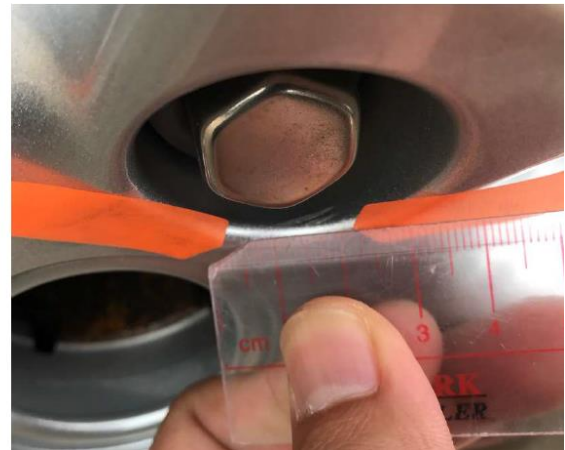
11. Water ingress caused by poor seals, etc.

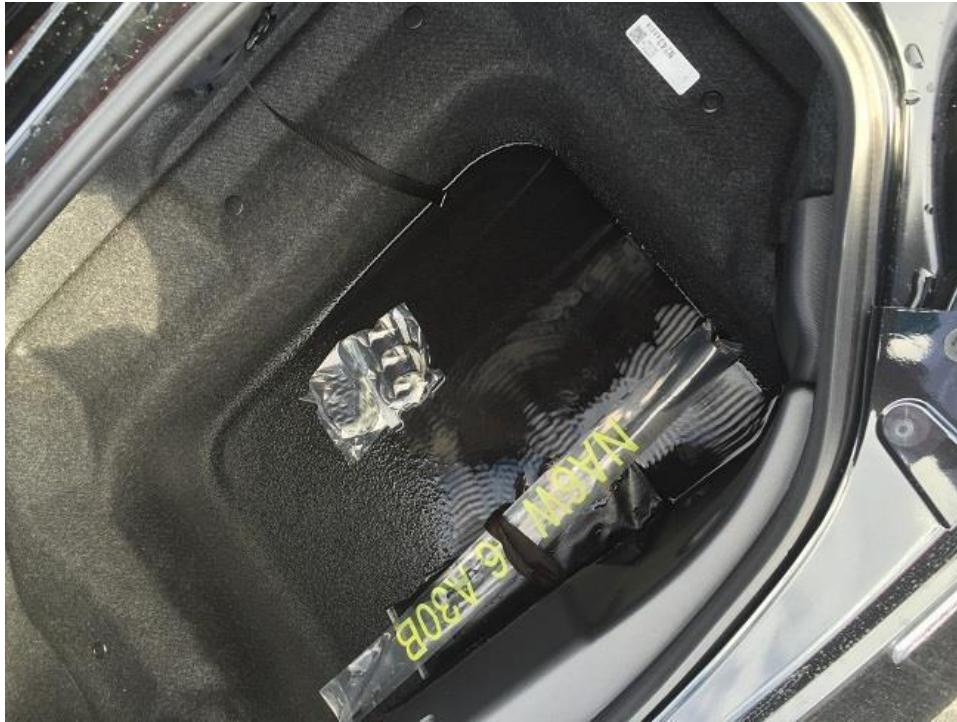
12. Damage in body gaps or panel edge chips on areas not accessible in transit (e.g. inner edges, adjacent fixed panels, etc.)

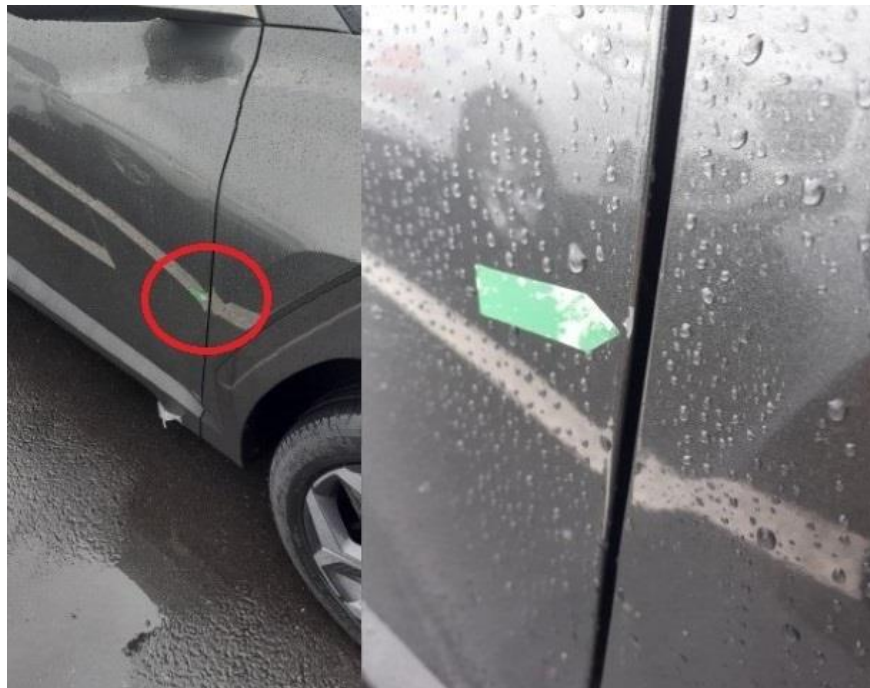
13. Punctured tyre caused by any factory screw or fixing

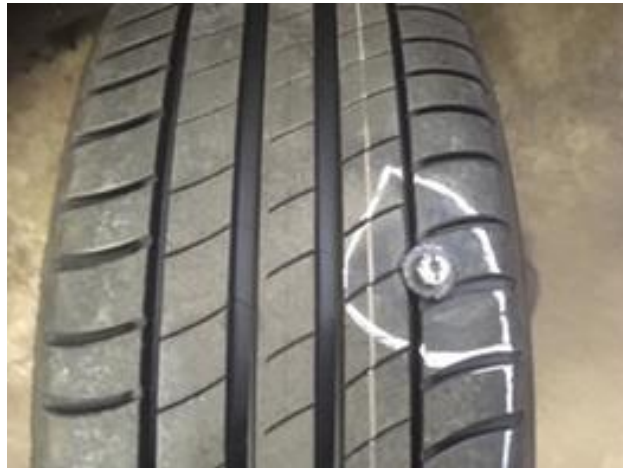
14. Detached or improperly installed exterior vehicle parts not showing evidence of impact or interference (e.g. emblems, badges, mud guards, roof rails)

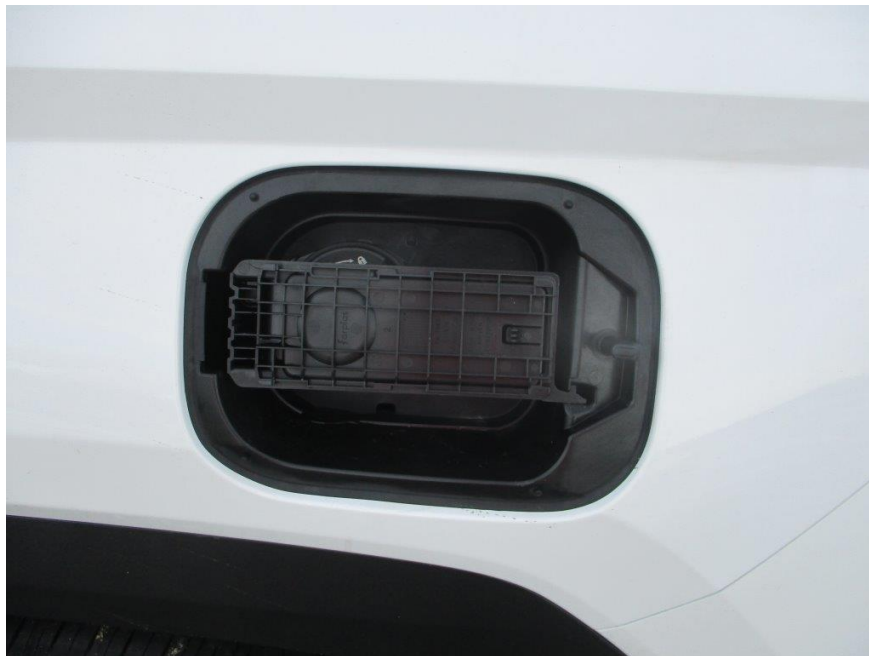
15. Missing, soiled or damaged interior components outside the driver's cockpit area or within the cockpit area but without clear signs of LSP liability

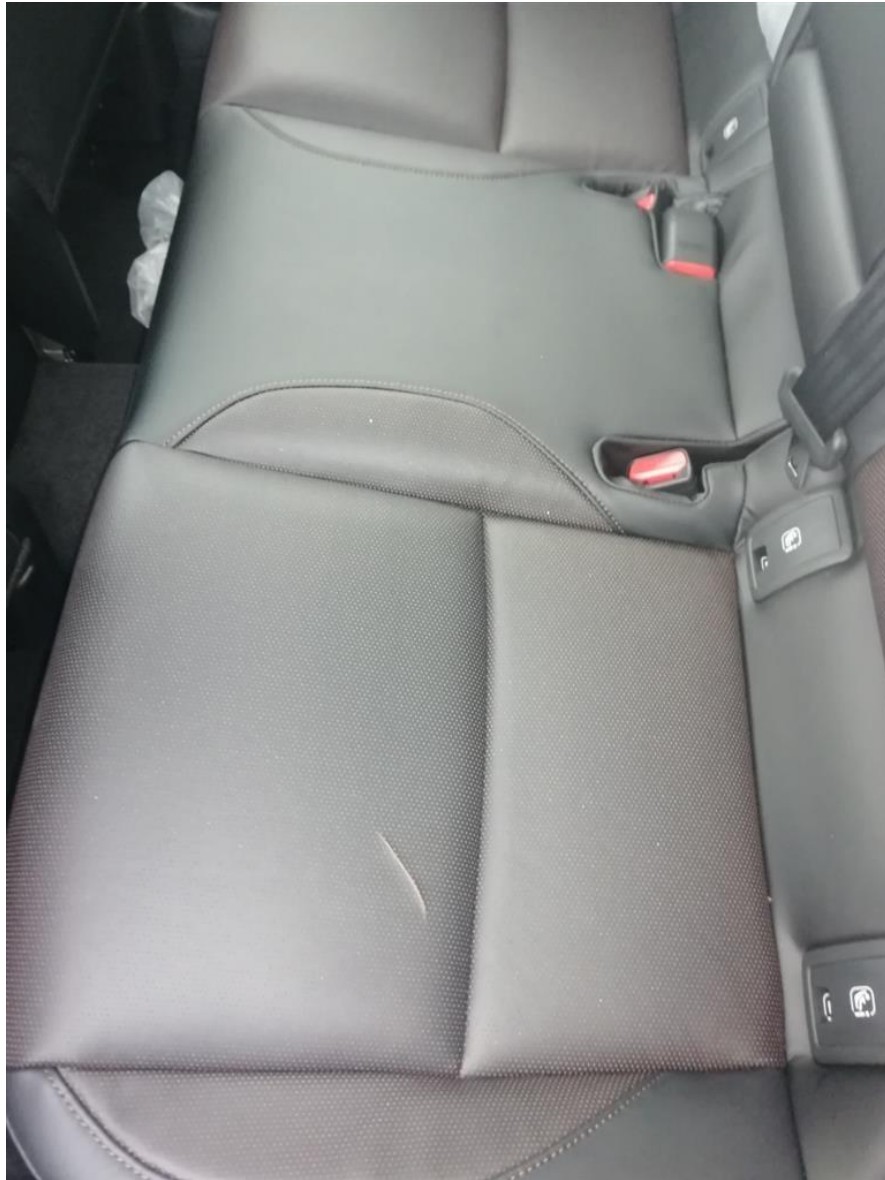
(rear seats, not part of standard visual inspection)

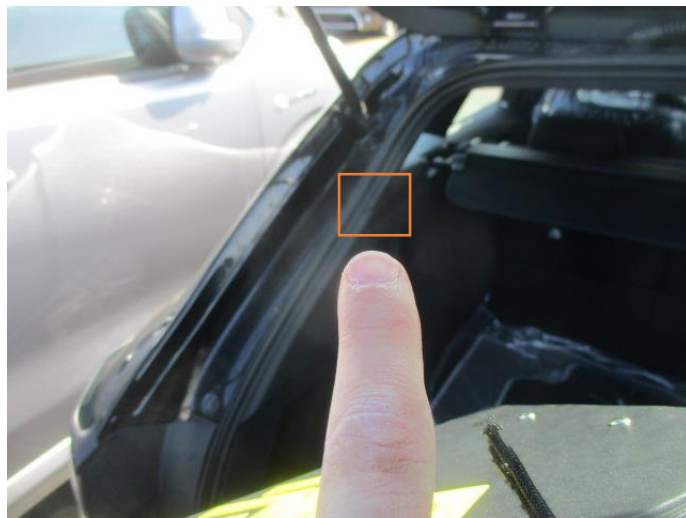
16. Improperly installed interior components
