Good practices for protection measures in vehicle handling and transportation

April 2026

The Association
of European
Vehicle Logistics

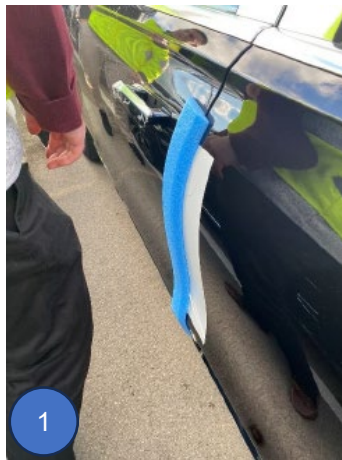
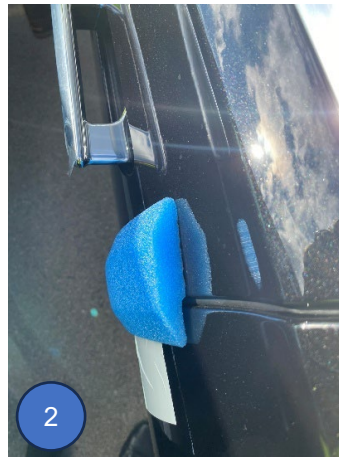
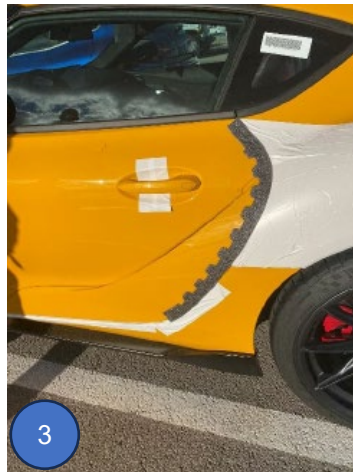
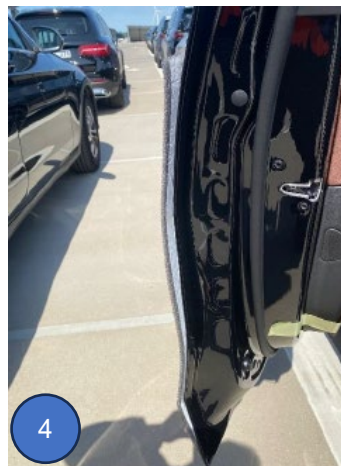
(Source: UCM Global)

- Install a wide enough foam protection on the door edge – covering also the front area of the rear door for a better protection. *(See picture 2 below.)*
- It should be long enough to cover the full length of the door. If the door has a curve, it might make it impossible to use one piece of foam protection and thus two pieces could be applied.
- The smaller foam pad may not cover all areas of risk.

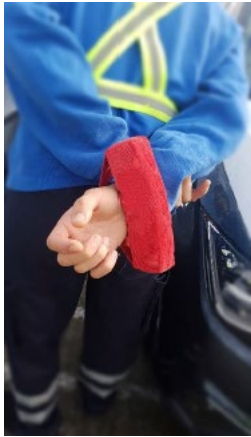
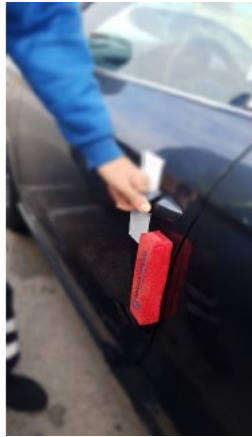
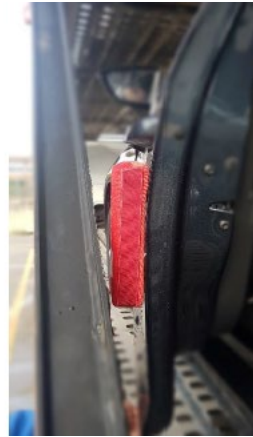
(Source: UCM Global)

- Portable magnetic door edge protection pad
 - magnet woven into the cloth so no metal-to-metal contact
 - it can be used on terminals, trucks and train or in any situation where the space is limited

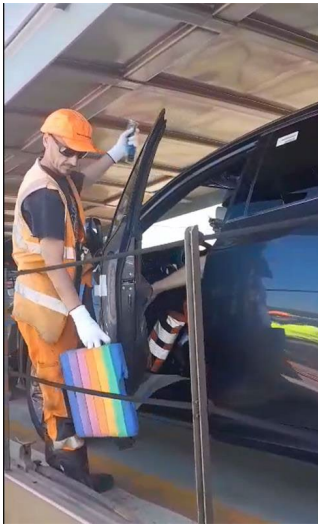
(Source: BLG Autorail)

- Process to protect the vehicles on rail wagons:
 - additional person opens the door for the driver and places a foam pad against the rail guard to protect the door (*See on the left*)

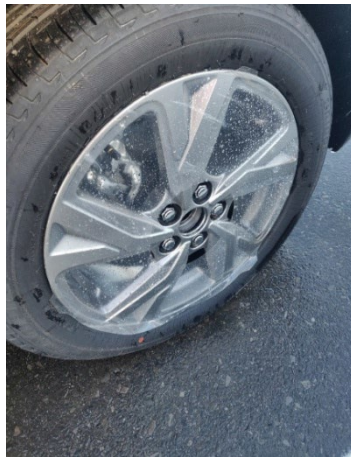
(Source: Mosolf)

- Problematic area for the complete logistics chain (rail, road, maritime transport and terminal handling).
- Good solution: plastic cover applied on the wheel rim
- Possible issues in maritime transport:
 - Tyre protection limits the ability to lash through the wheels on board vessels
 - Taking off the plastic cover can also lead to damages
- If the plastic cover is damaged it should be mentioned in the damage report for a better liability establishment.
- Some OEMs ask for the damaged protection to be removed to check for damages to the wheel rim.

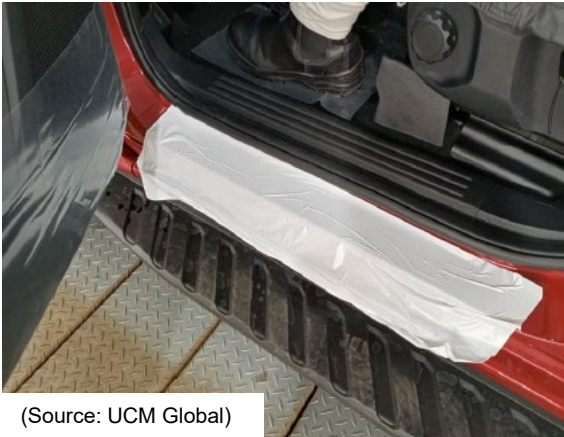
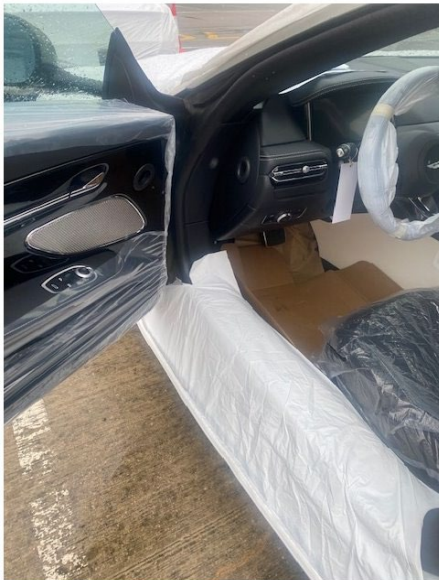
(Source: UCM Global)

- Problematic area for the complete logistics chain (rail, road, maritime transport and terminal handling).
- 3 sensitive areas to protect:
 - Door's lower part
 - Door sill
 - B-pillar – it can be scuffed as the driver or the stevedore gets in the vehicle
- Good solution: complete coverage of the door sill and the lower part of the driver's door
- The shorter covers may not protect all areas of risk
- If the protection is damaged, it has to be noted on the damage report.
- Some OEMs ask for the protection to be removed if it is loose or damaged.

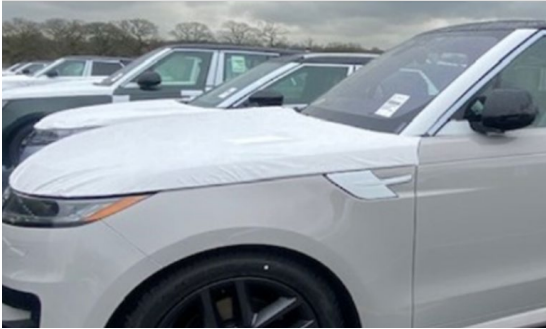
(Source: JLR)

- Wrap-guard applied on high-risk areas
 - Some OEMs ask for the protection to be removed if it is loose or damaged.

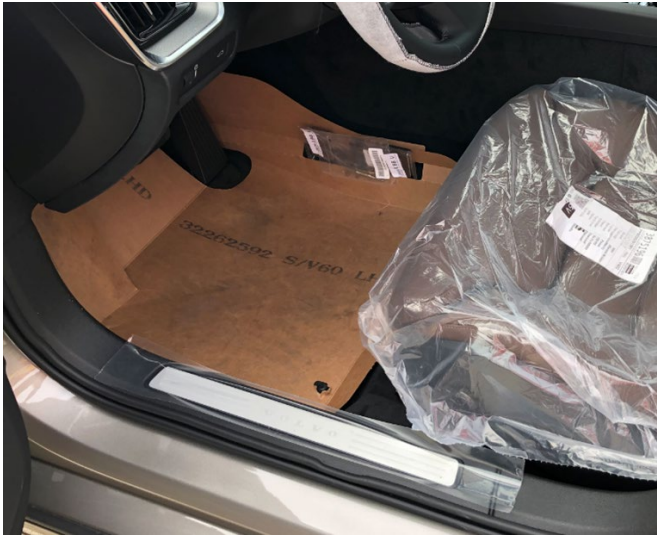
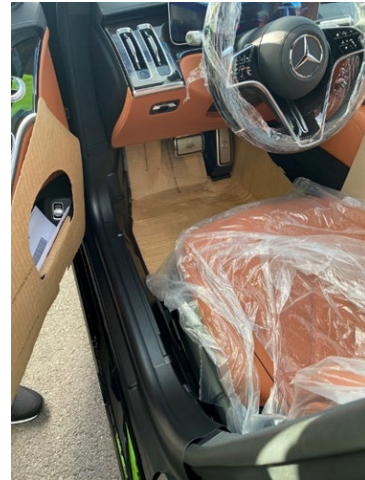
(Source: UCM Global)

- Floor carpet protection

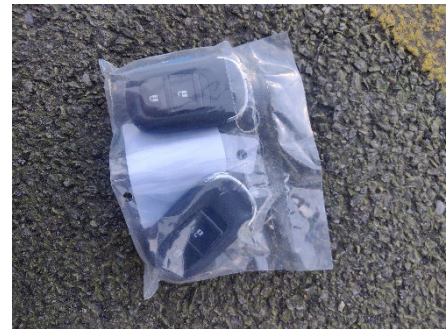
(Source: Mosolf)

- Key fobs can be stolen or damaged, therefore they have to be protected but they still need to be usable during transport
